Debris Analysis - Main Landing Gear Trunnion Door Panel

by Blaine Gibson and Richard Godfrey

12th December 2022

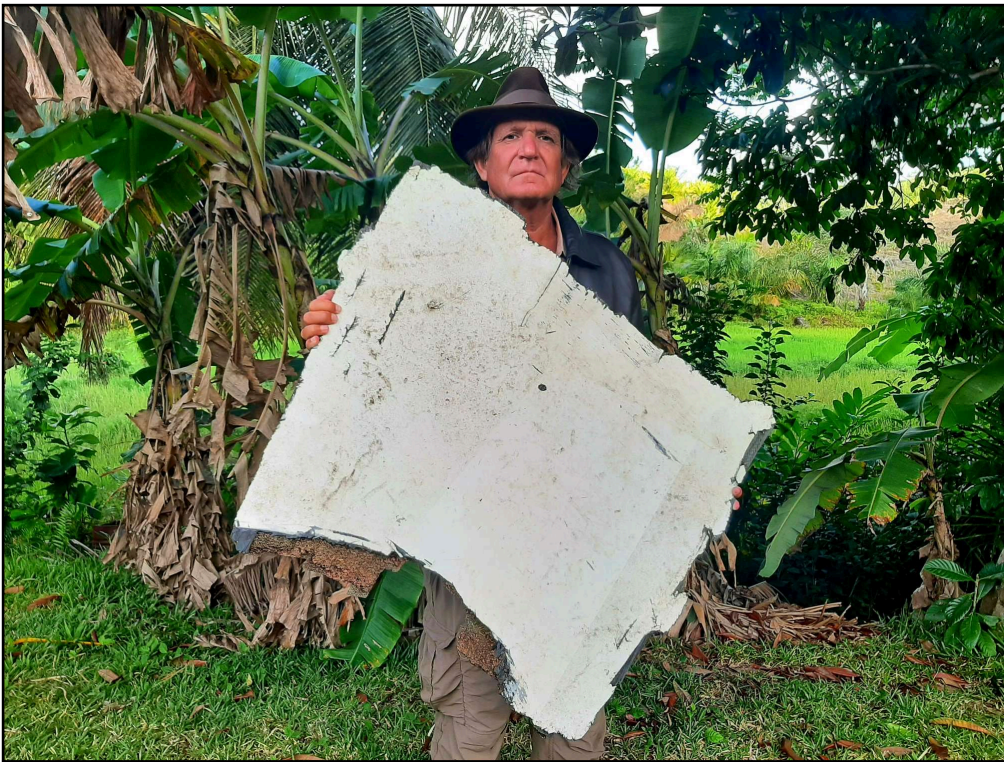
The debris is white on one side and black on the other side with brown honeycomb in between. The debris item was slightly curved and measured 32" x 28" (81.3 cm x 71.1 cm).

Figure 8: Debris Item White Side.

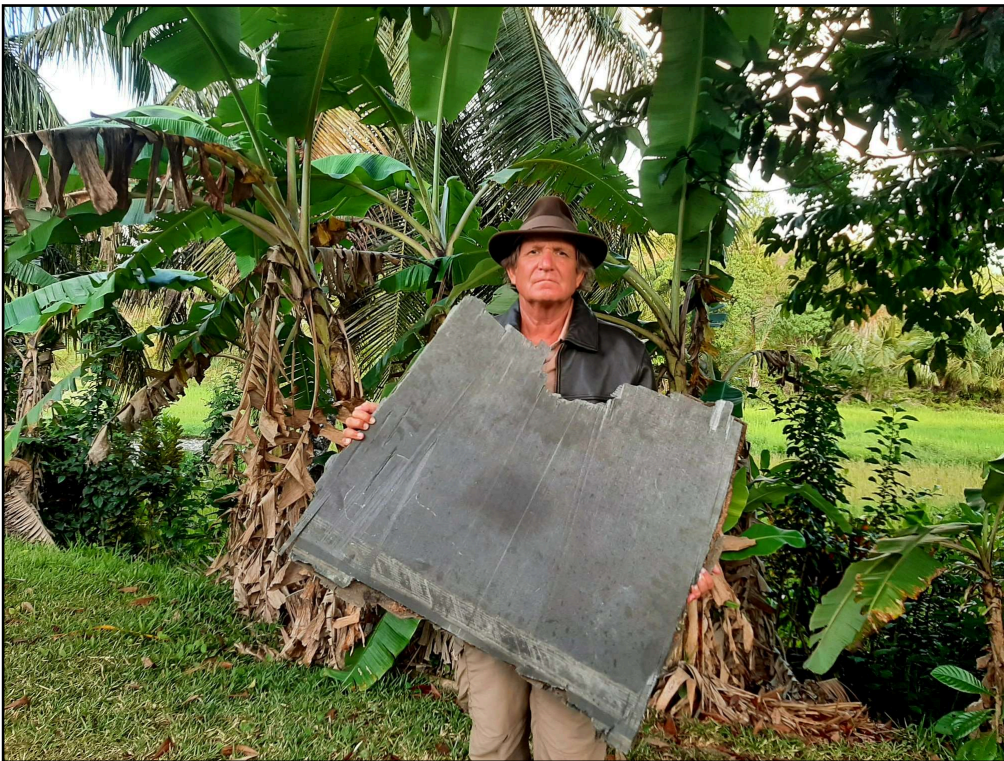
Figure 9: Debris Item Black Side.

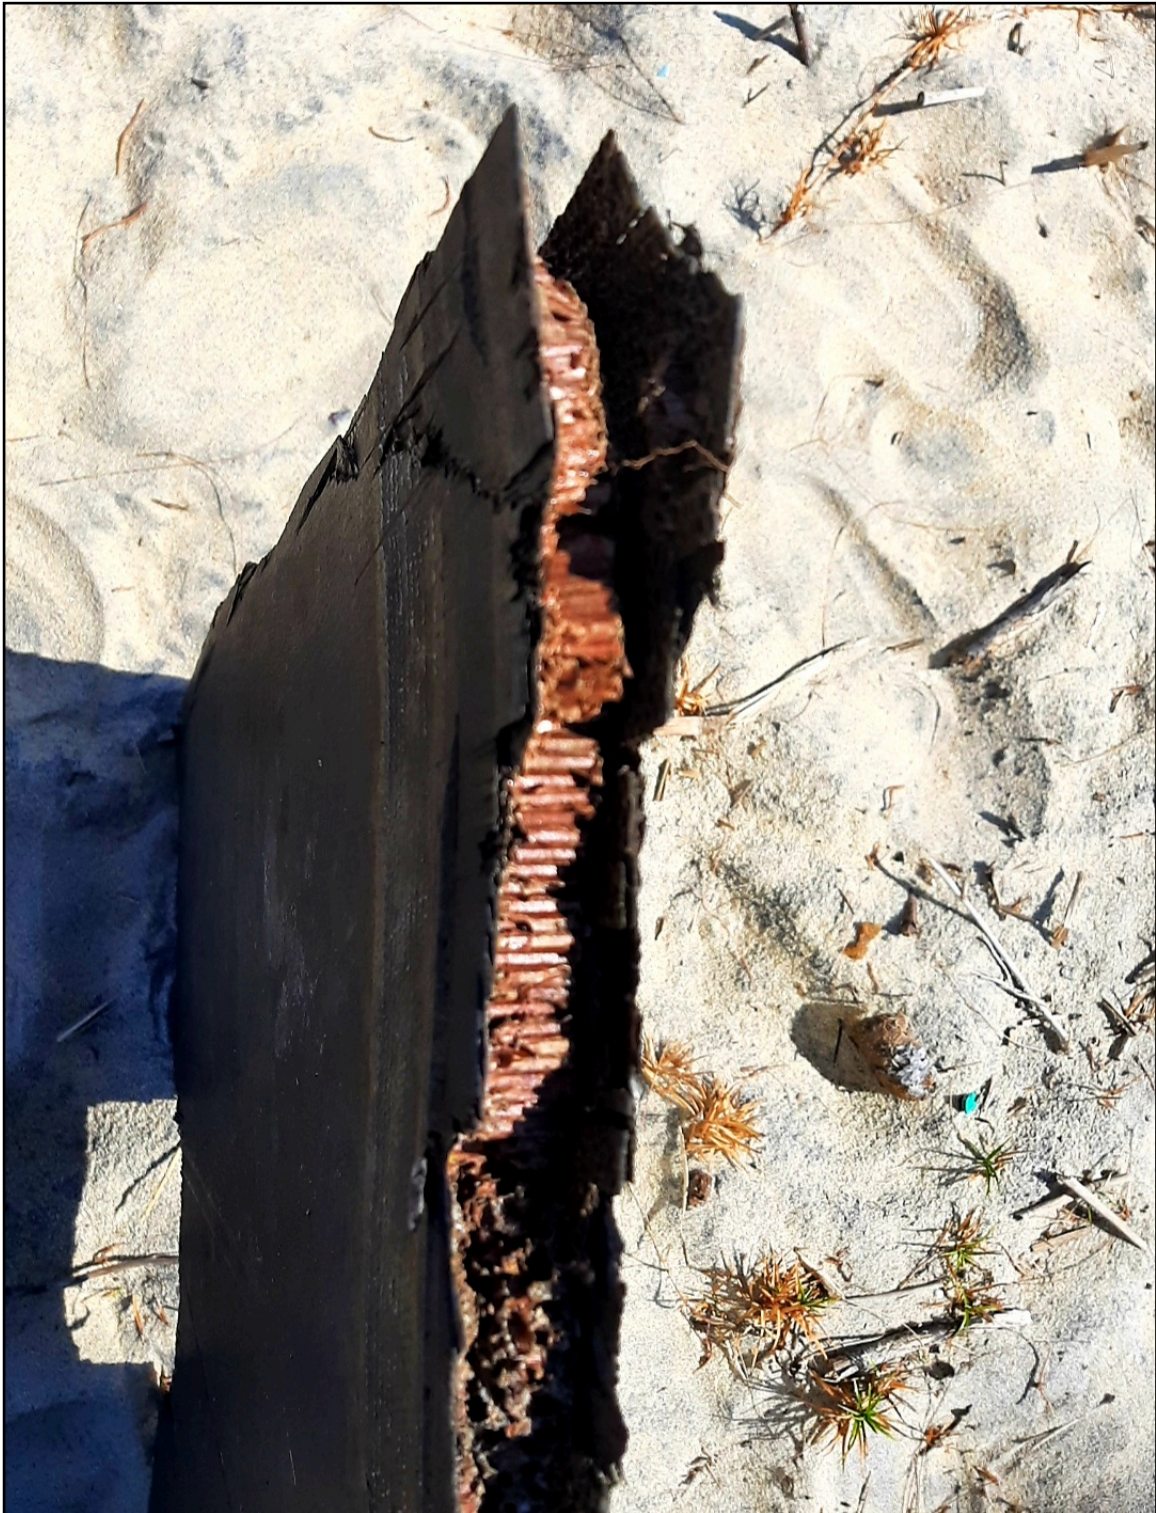
The debris item is light weight and 1" thick (2.54 cm). The thickest part of the honeycomb is 1" but in some parts it appears to have been compressed to 7/8" or 3/4".

Figure 10: Debris Item Honeycomb Sandwich.

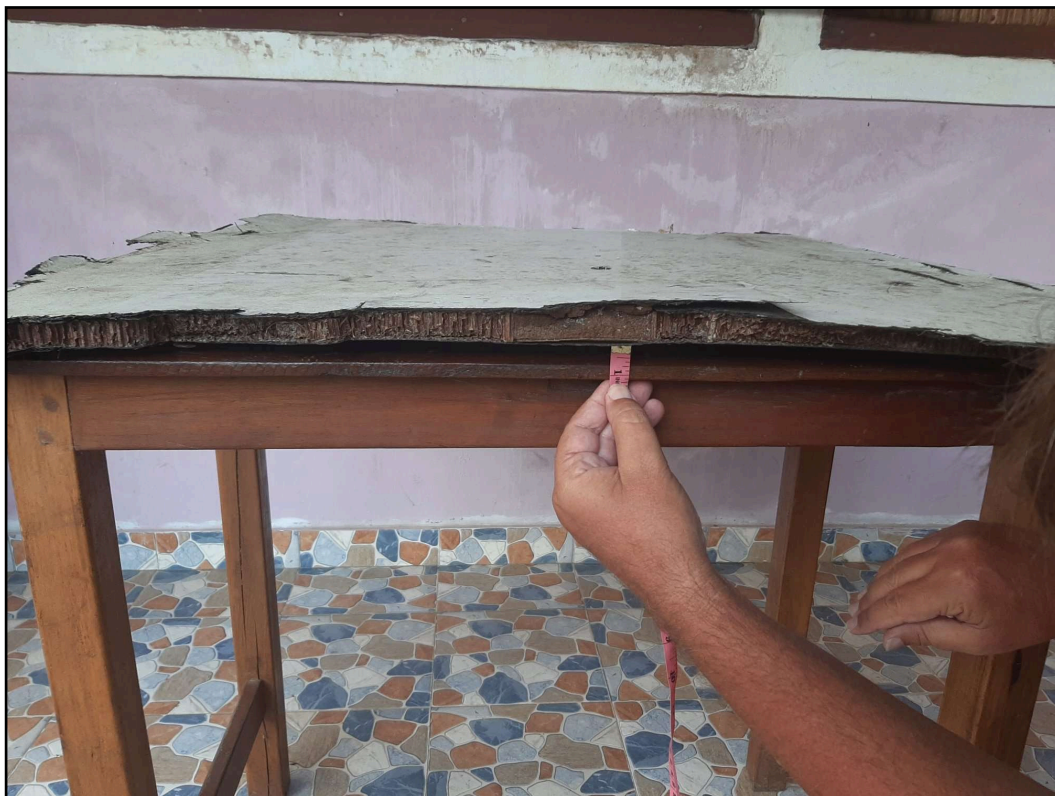
The white side is slightly convex, the black side is slightly concave.

Figure 12: Debris Item Side View with maximum 3/4" curvature.

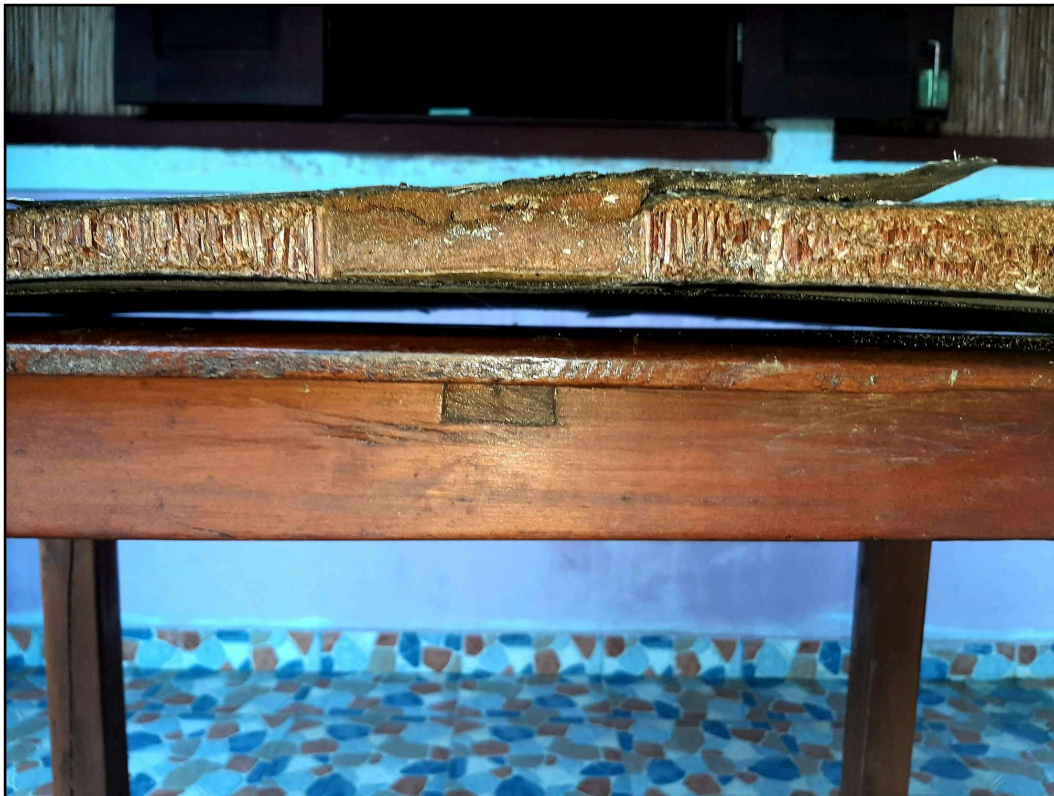
The sandwich is mostly honeycomb based but partly a more solid material.

Figure 13: Debris Item Side View with honeycomb and a more solid fill.

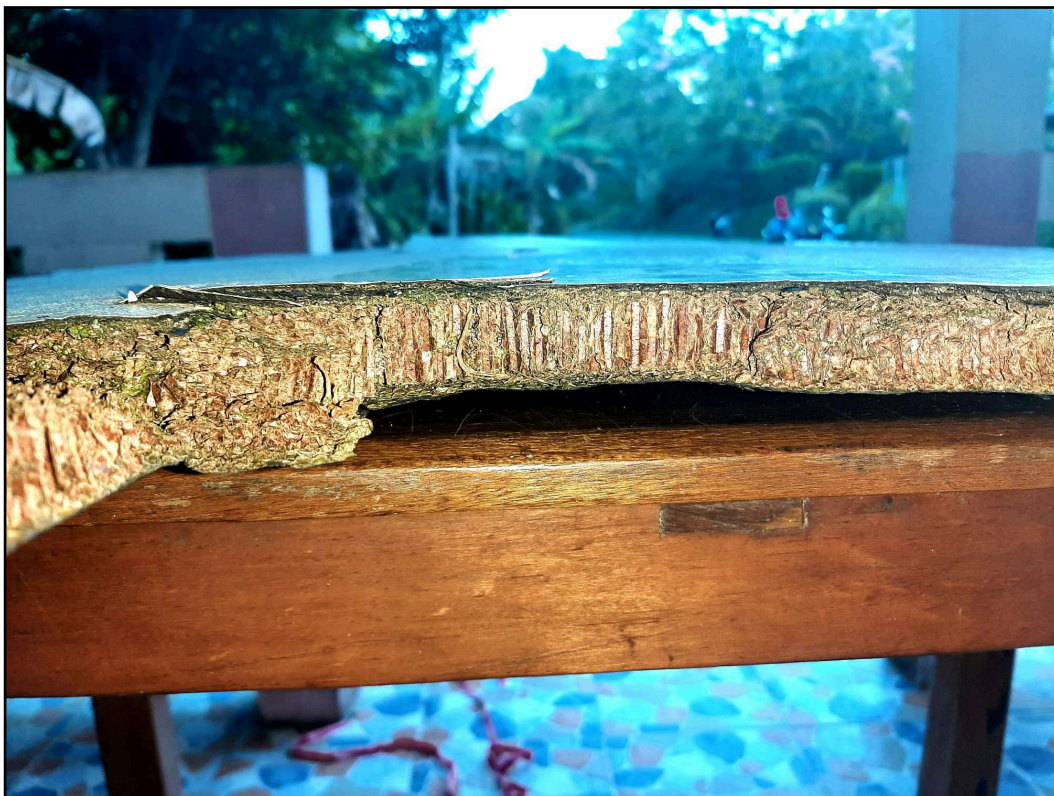
Figure 14: Debris Item Side View with different thicknesses.

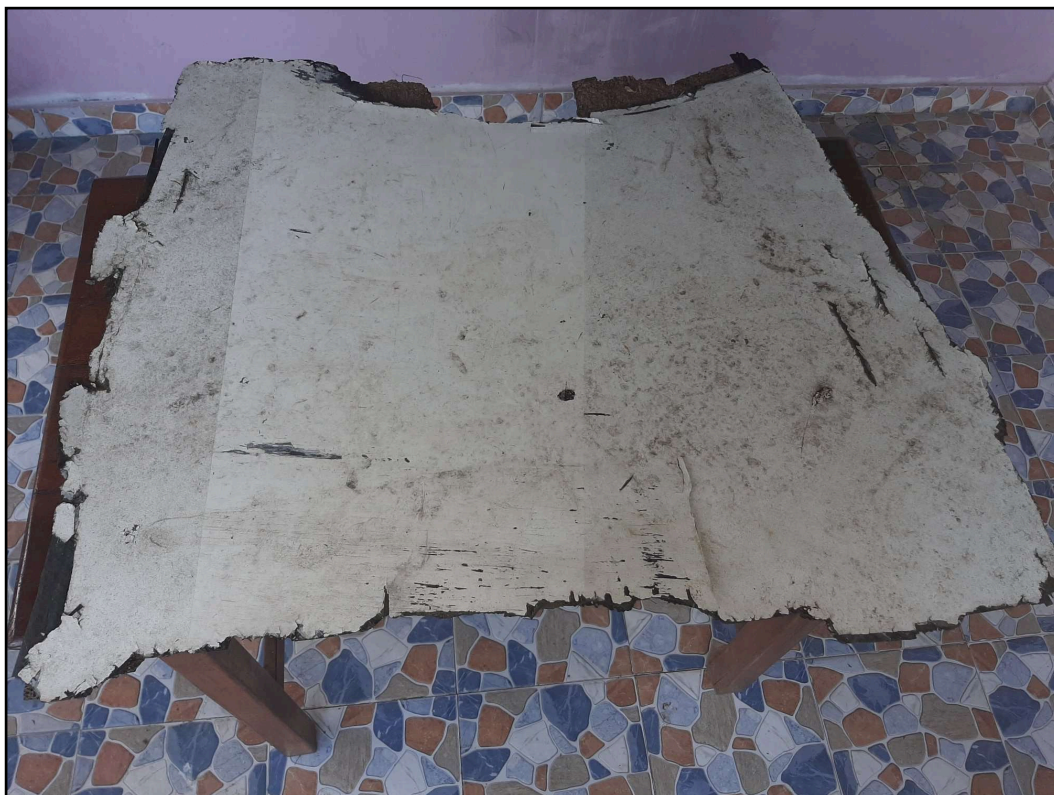
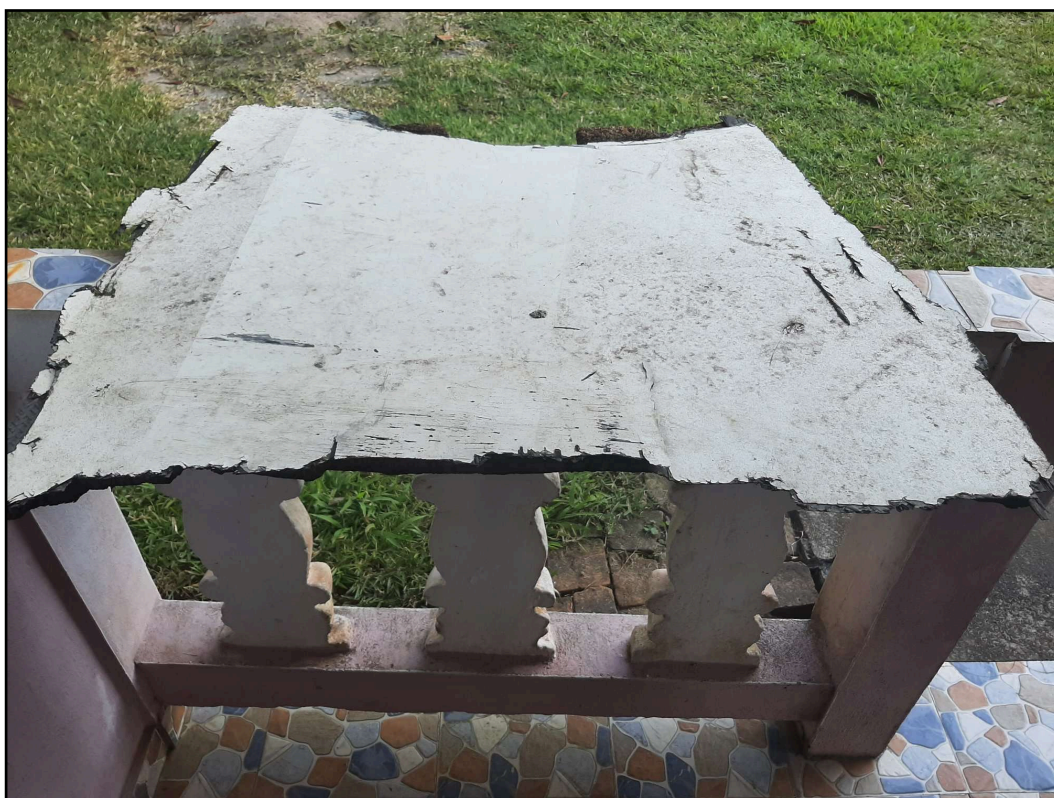
The debris item has a clearly delineated smooth area in the middle surrounded on both sides with areas which are rougher to the touch.

Figure 15: Debris Item White Side View with different areas.

Figure 16: Debris Item White Side View with different areas against daylight.

In Figure 15 we indicate that the debris item has a clearly delineated smooth area in the middle surrounded on both sides with areas which are rougher to the touch.

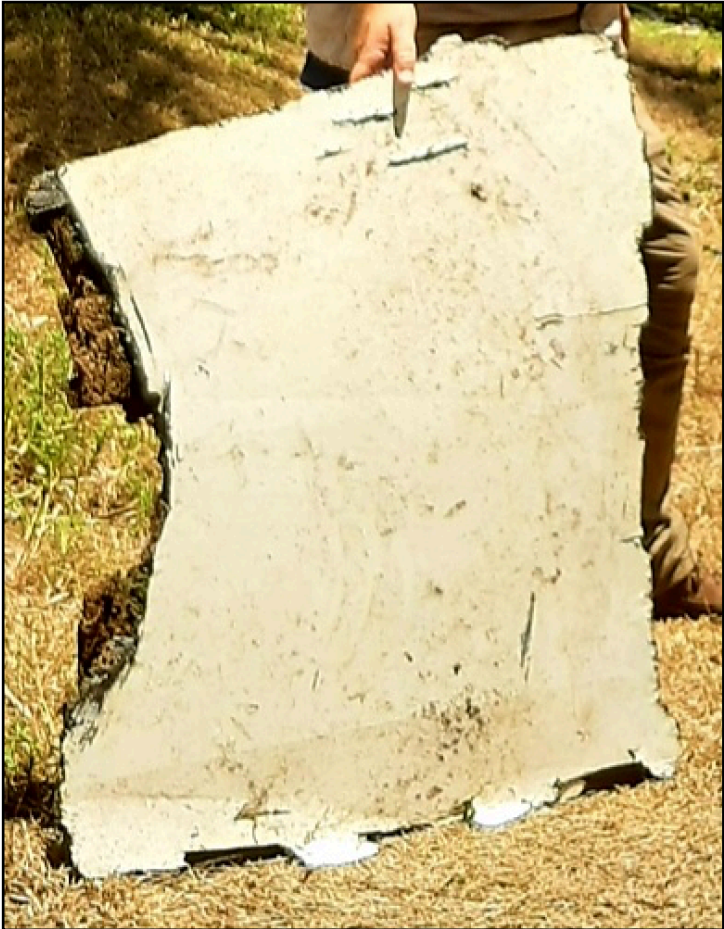
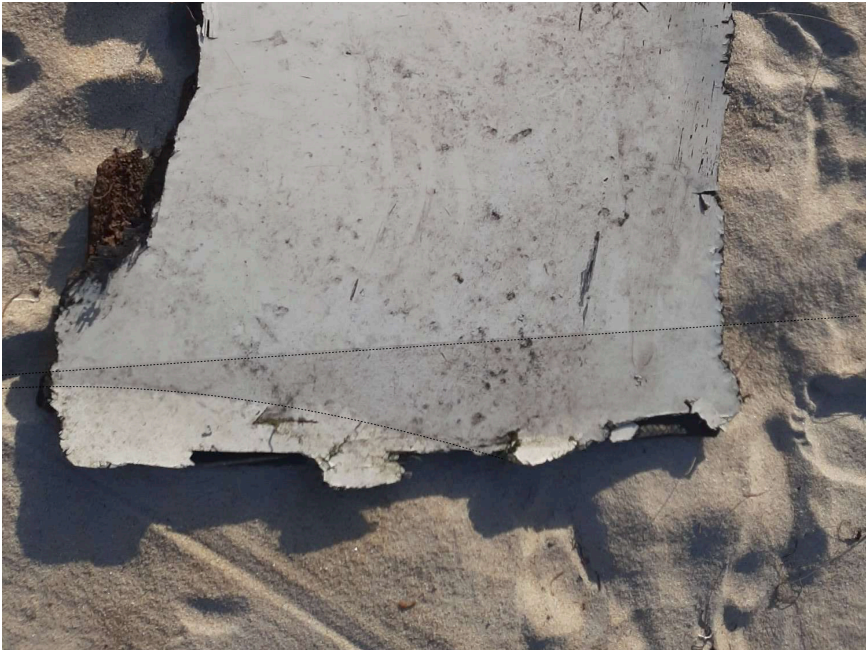
The debris item white side shows a distinct straight line and curved line, which has been outlined in Figure 18 below.

Figure 17: Debris Item White Side View with straight and curved line.

Figure 18: Debris Item White Side View with straight and curved line (photo enhanced).

From the slightly convex white side as well as the curvature line seen in Figure 18, we conclude that the white side was on the exterior and the black side was on the interior of the aircraft. It is possible that the debris item is part of the small landing gear door at the root of the wing.

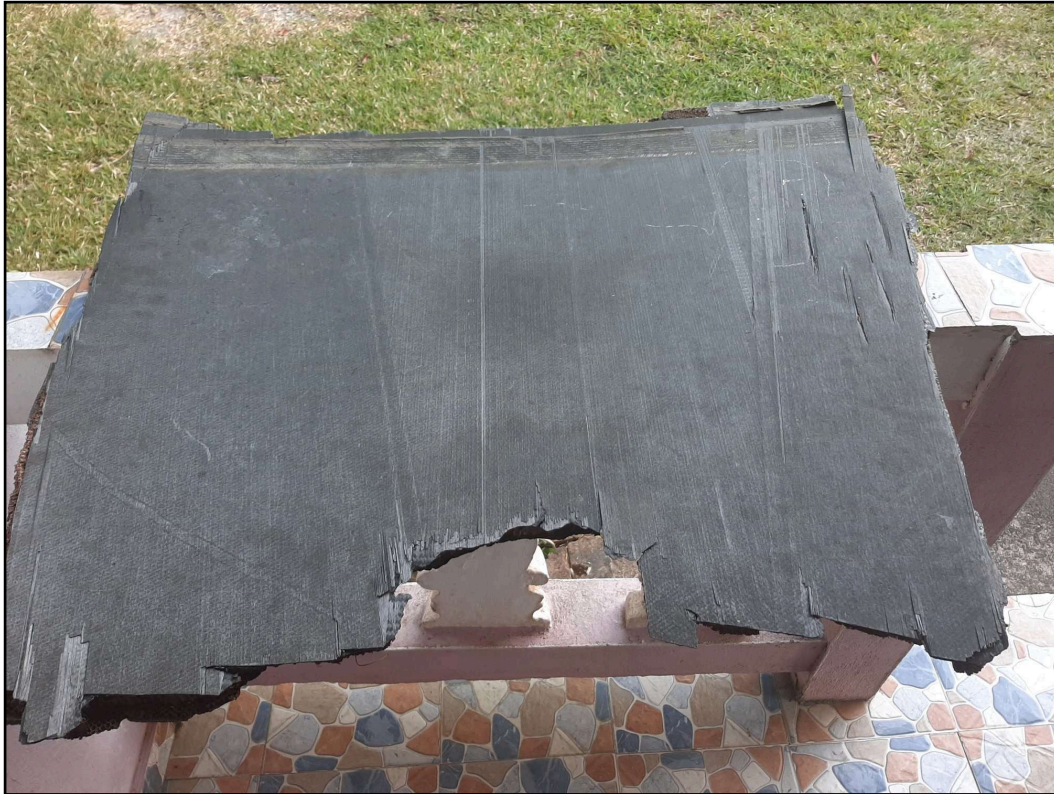
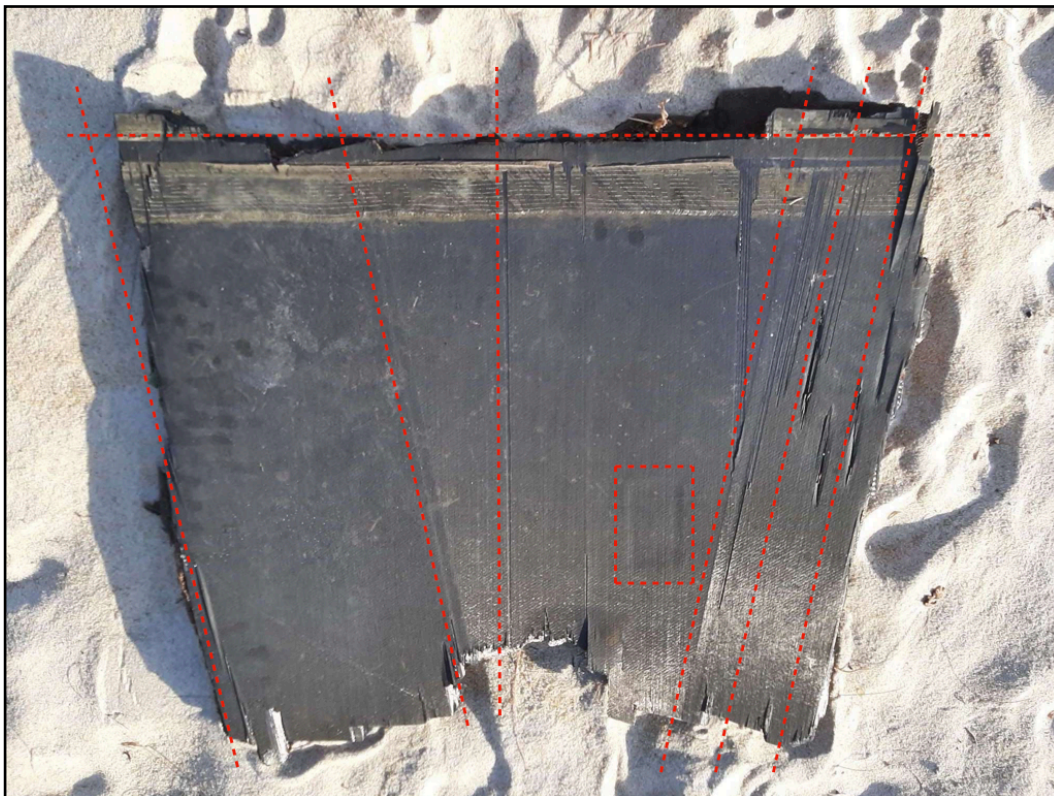
The debris item black side shows clear lines and structure, which have been outlined in Figure 20 below. There is a rectangular indent, which is possibly where a base plate was positioned.

Figure 19: Debris Item Black Side View showing lines and structure.

Figure 20: Debris Item Black Side View showing lines and structure (photo enhanced).

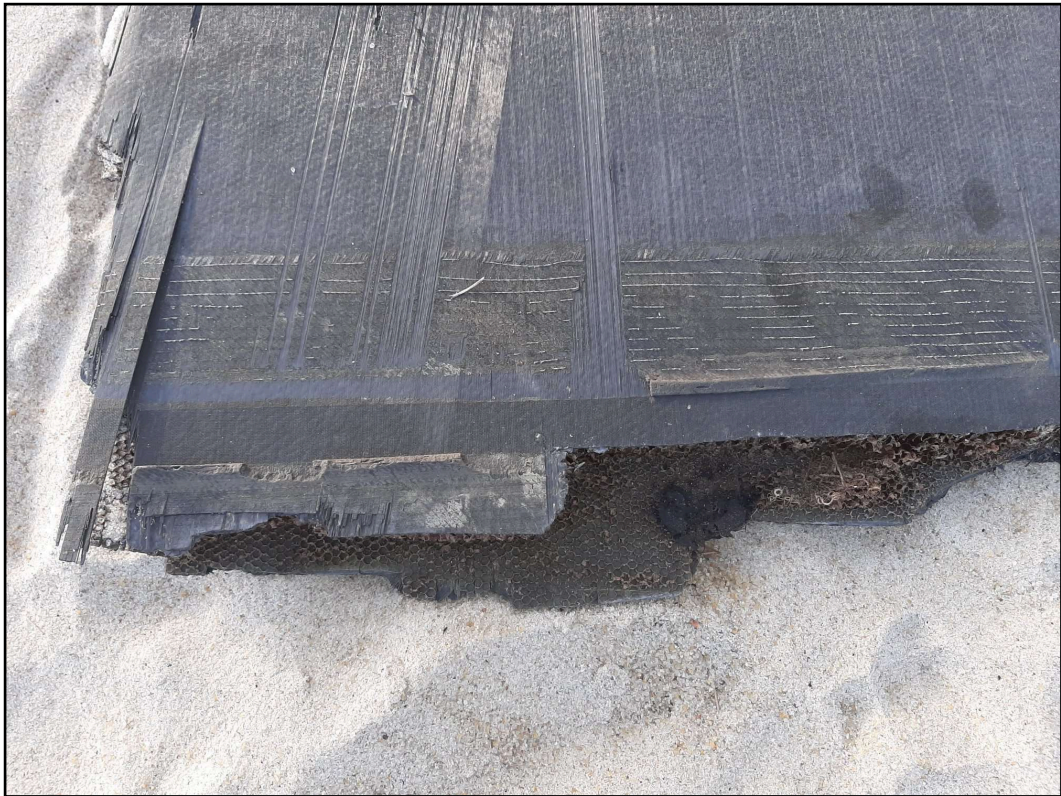
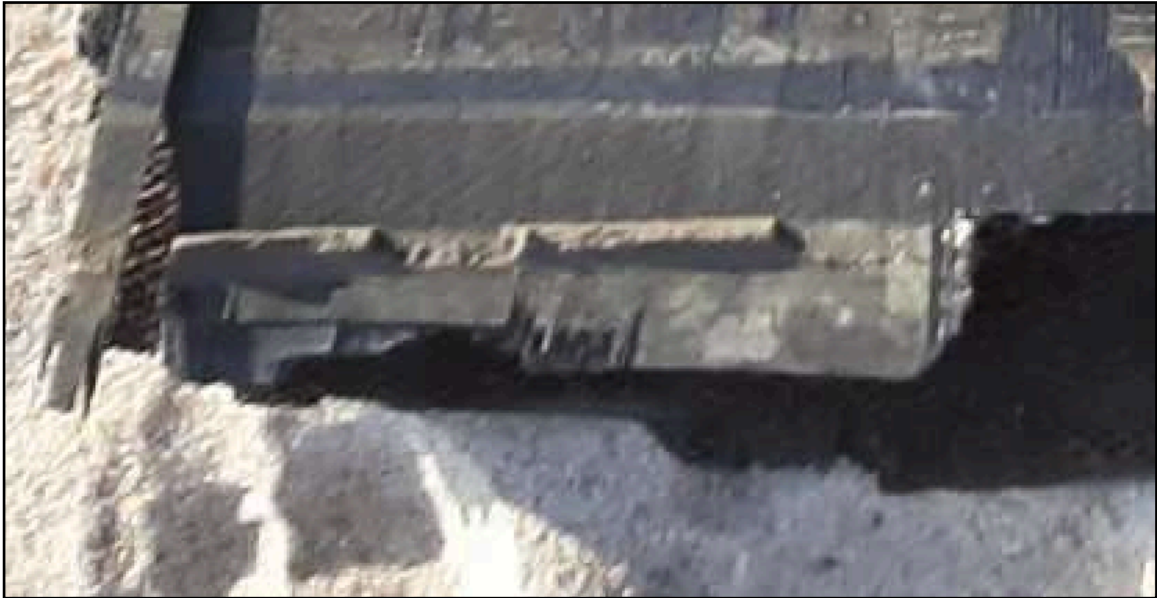
There are remnants of a stripe along one edge and an attachment, where possibly a hinge was previously fixed.

Figure 21: Debris Item Black Side View showing stripe and attachment.

Figure 22: Debris Item Black Side View showing attachment.

The trunnion door has a back cover plate with a single fixing. No hinge fitting or door latch is evident in Figure 50 below. If the cover plate was ripped off from the black side of the debris item leaving fracture damage on all four edges, then the impact force was considerable. The attachment shown in Figure 22 is possibly the remnant of the back cover plate fixing at that point. The single rectangular indent shown in Figure 20 is a possible match for the base plate of the single fixing on the main landing gear trunnion door. The trunnion door is light weight.

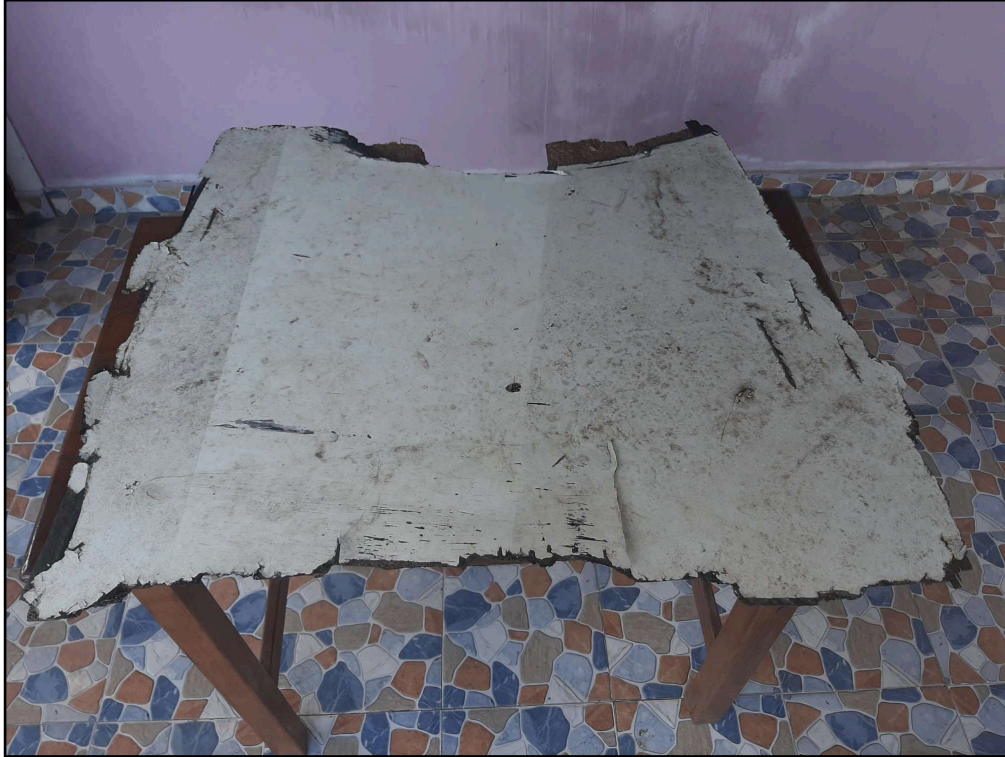
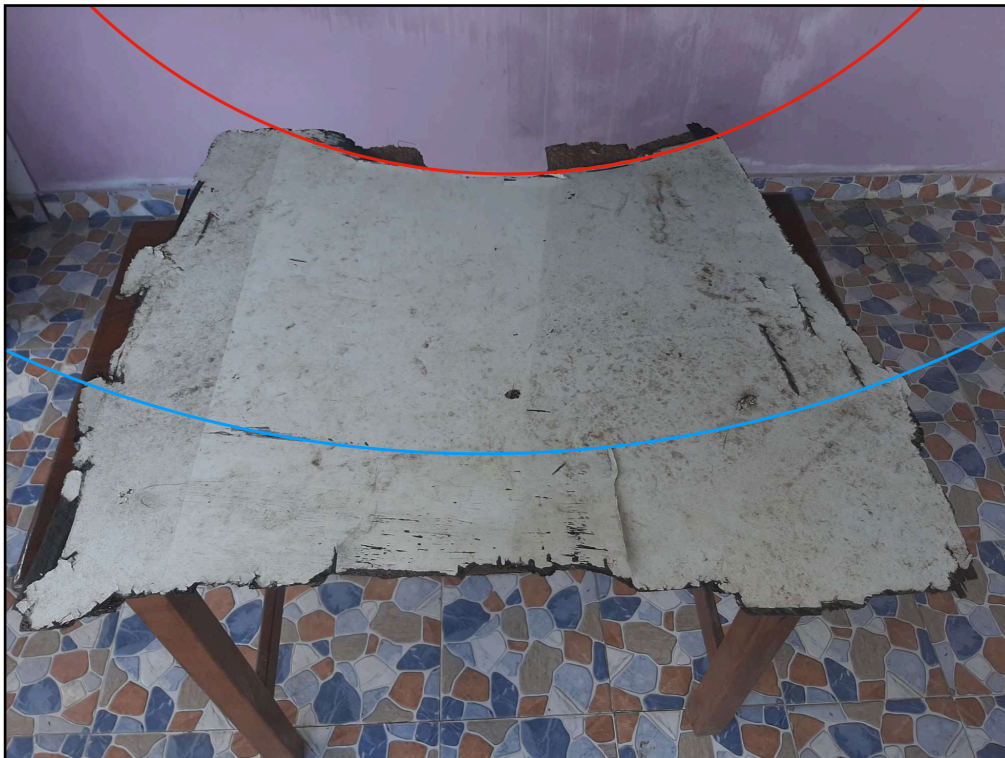
The debris item shows cuts, scratches, pits and tears on all sides. On one side the tear is circular marked in red in Figure 24. There is also a circular cut and circular scratch marking on the white side marked in blue in Figure 24. There are fractures on all four edges of the debris item.

Figure 23: Debris Item White Side with tears and circular marking.

Figure 24: Debris Item White Side with tears and circular marking (photo enhanced).

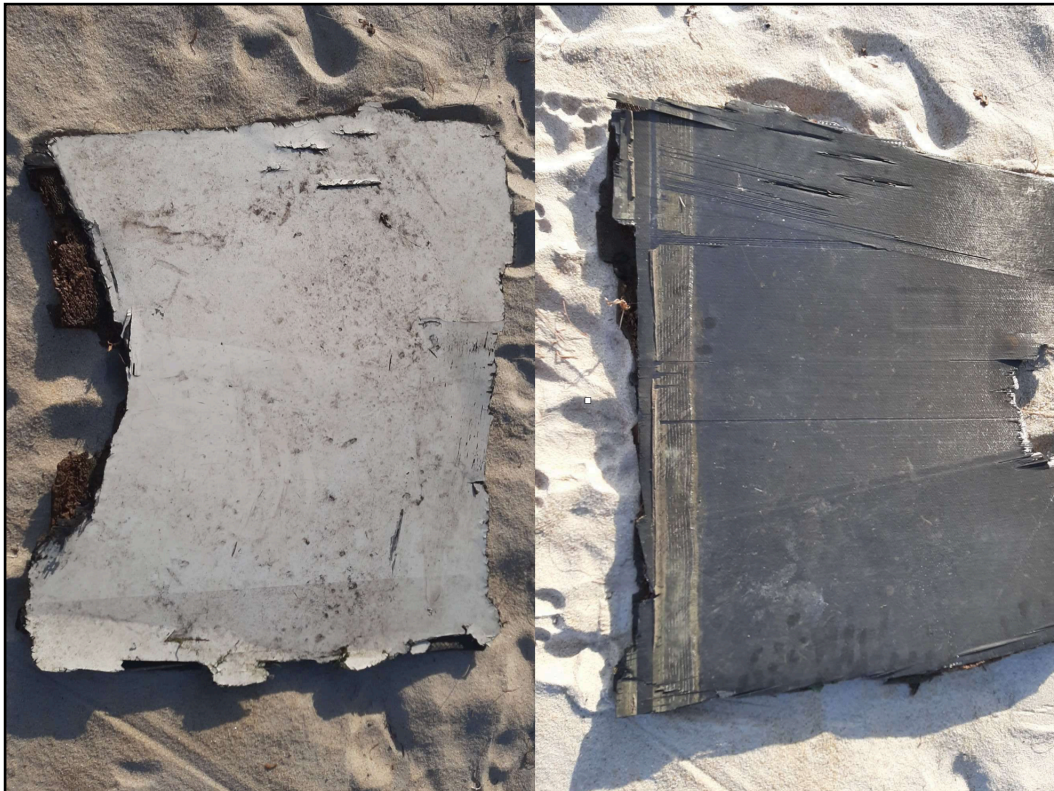
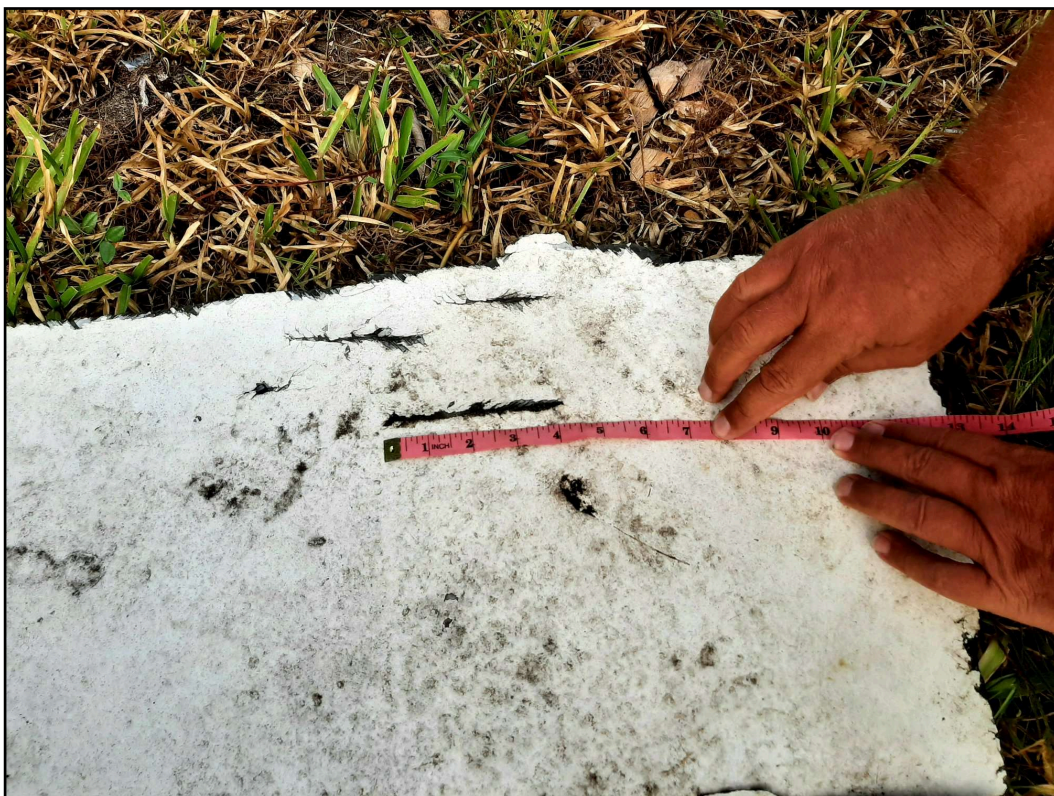
There is puncture damage penetrating right through the debris item, which upon closer examination is from the black side to the white side. There are 4 almost parallel slicing type punctures.

Figure 25: Debris Item with puncture damage both sides.

Figure 26: Puncture damage position 13" from the edge.

If an engine compressor ring penetrated the black side of the small door panel with considerable force on impact, then depending on the angle of impact, it is possible to cause the four parallel slices observed penetrating right through the debris item to the white side.

The fan blades are too wide and the turbine blades are too blunt, but the compressor blade rings range in width along the axis of the engine core from between 179 mm down to 96 mm (7.05" down to 3.78"). A compressor ring with a set of damaged blades of up to 4" in width fits the penetration observed in the debris item with slices of up to 4" long.

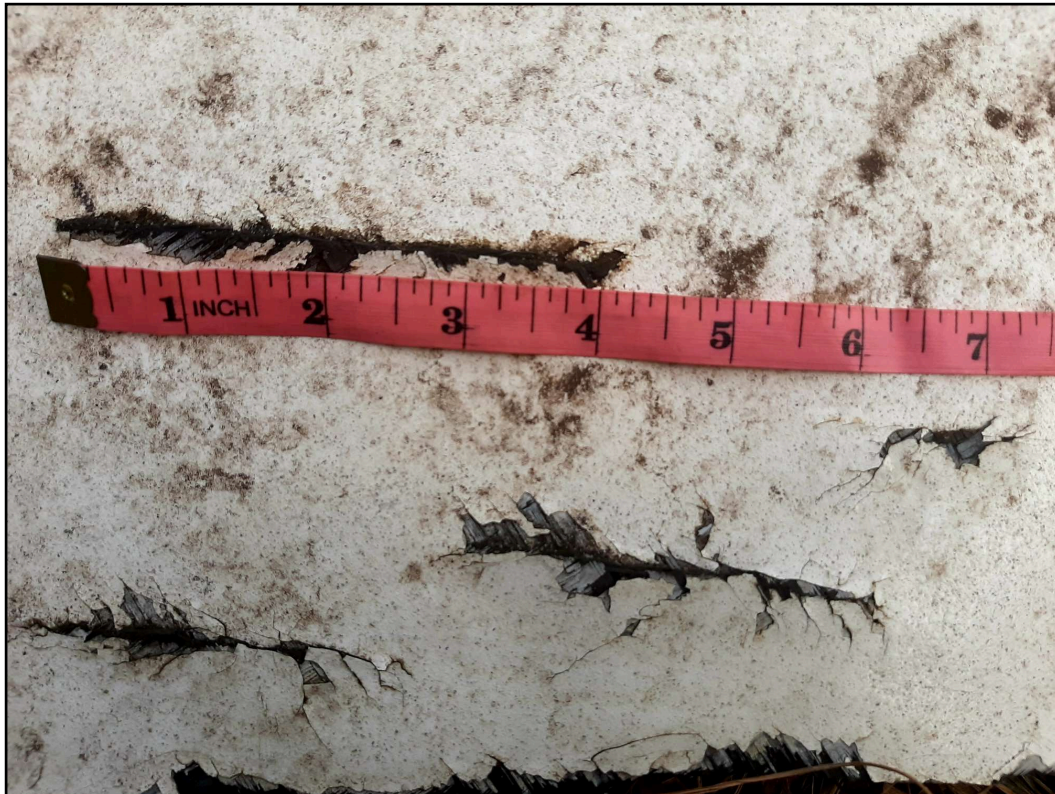
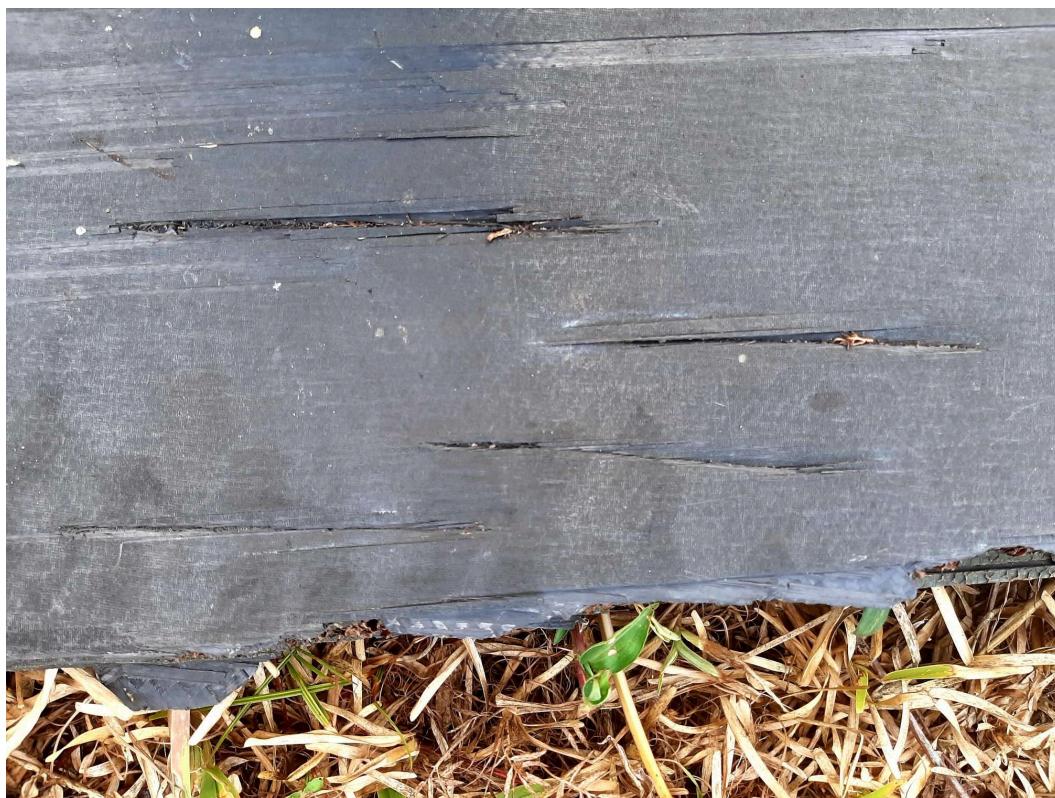
The largest puncture damage is 4" long and of narrow width.

Figure 27: Close up of puncture damage white side up to 4" long.

Figure 28: Close up of puncture damage black side (photo mirrored).

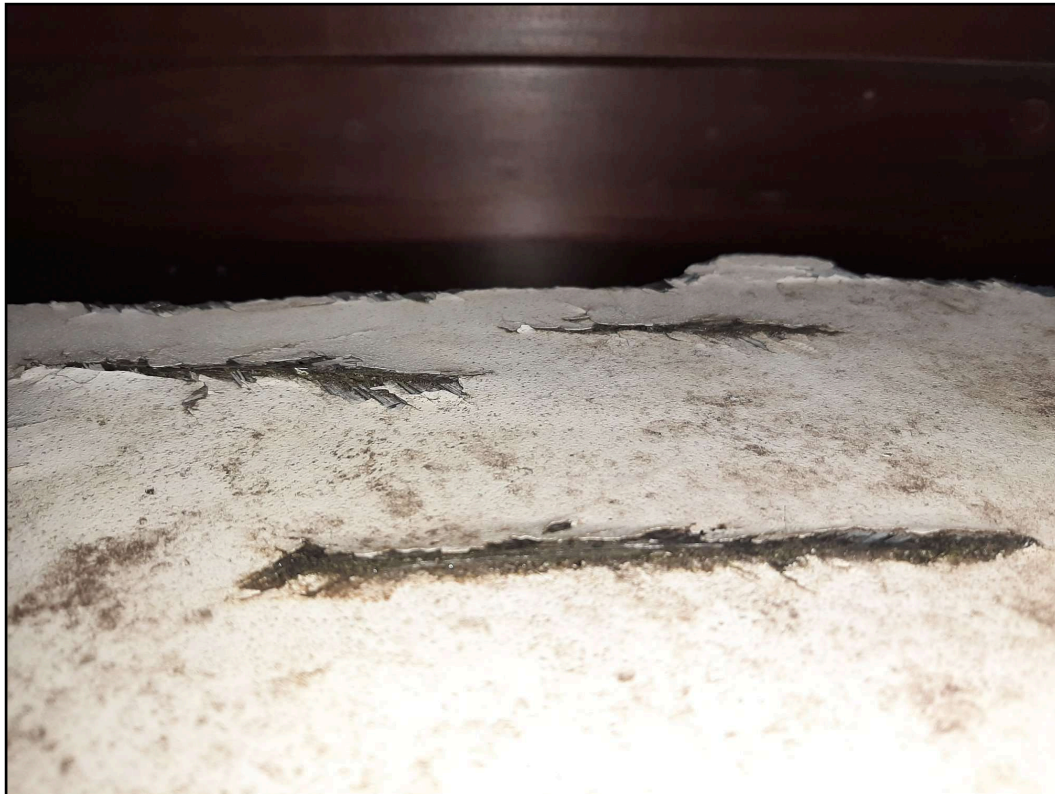
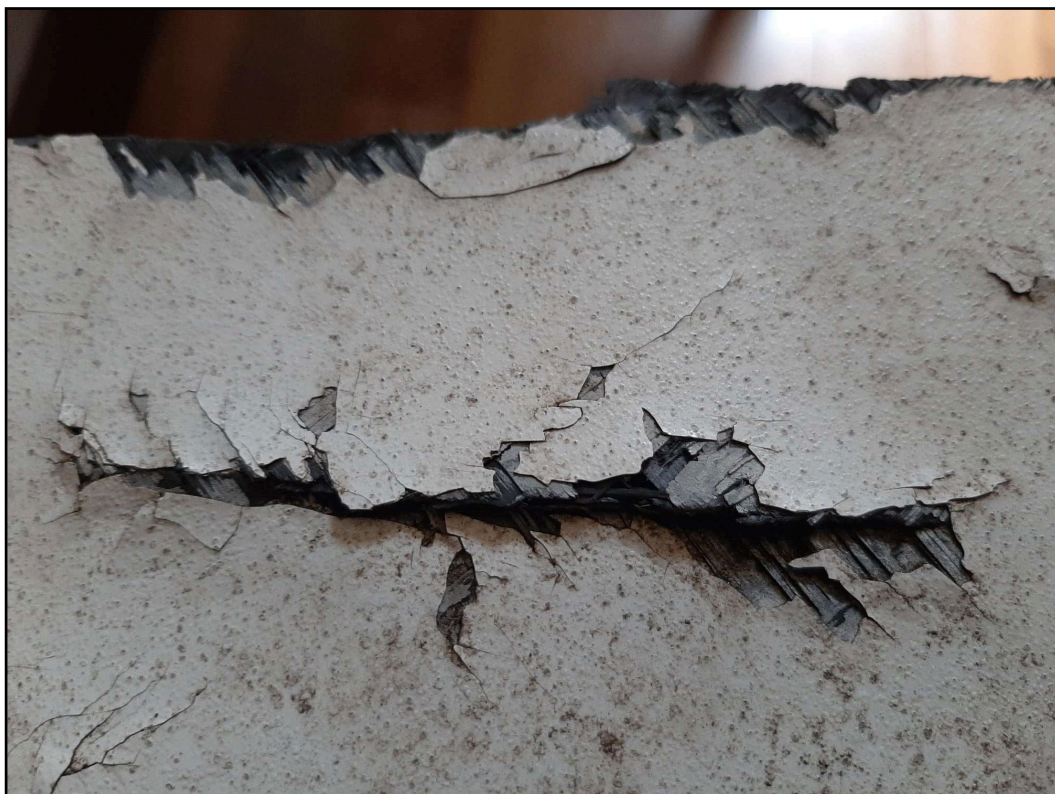
The lifting of the white surface is shown in Figure 29 in relief and in Figure 30 by the shadows.

Figure 29: Close up of the lifting of the surface of the white side.

Figure 30: Close up of the lifting of the surface of the white side with shadows.

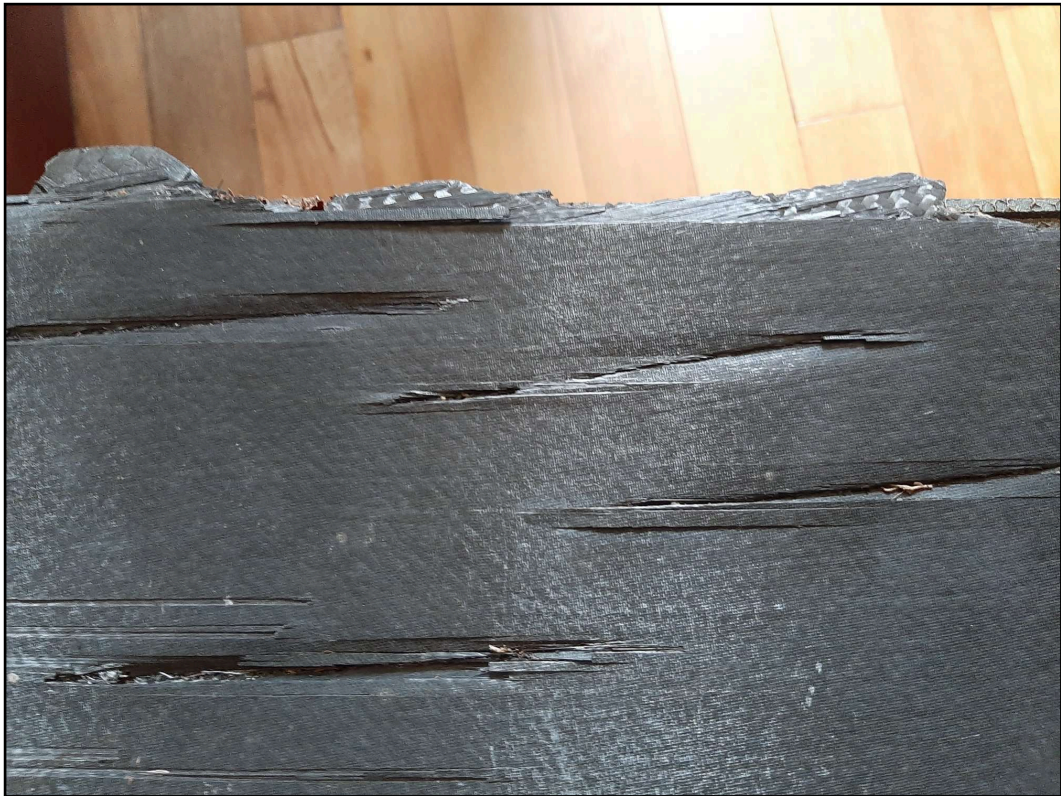
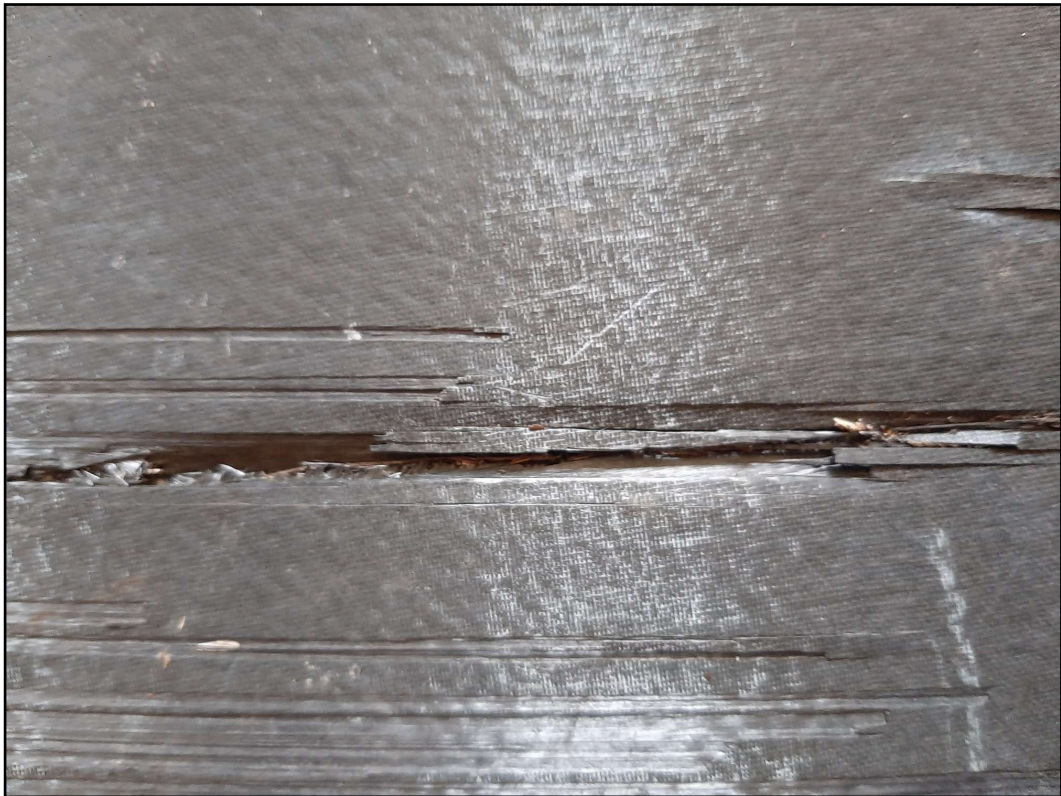
The indentation of the black surface is shown in Figure 31 and in close up of the largest indentation in Figure 32.

Figure 31: Close up of the indentation of the surface of the black side.

Figure 32: Close up of the largest indentation of the surface of the black side.

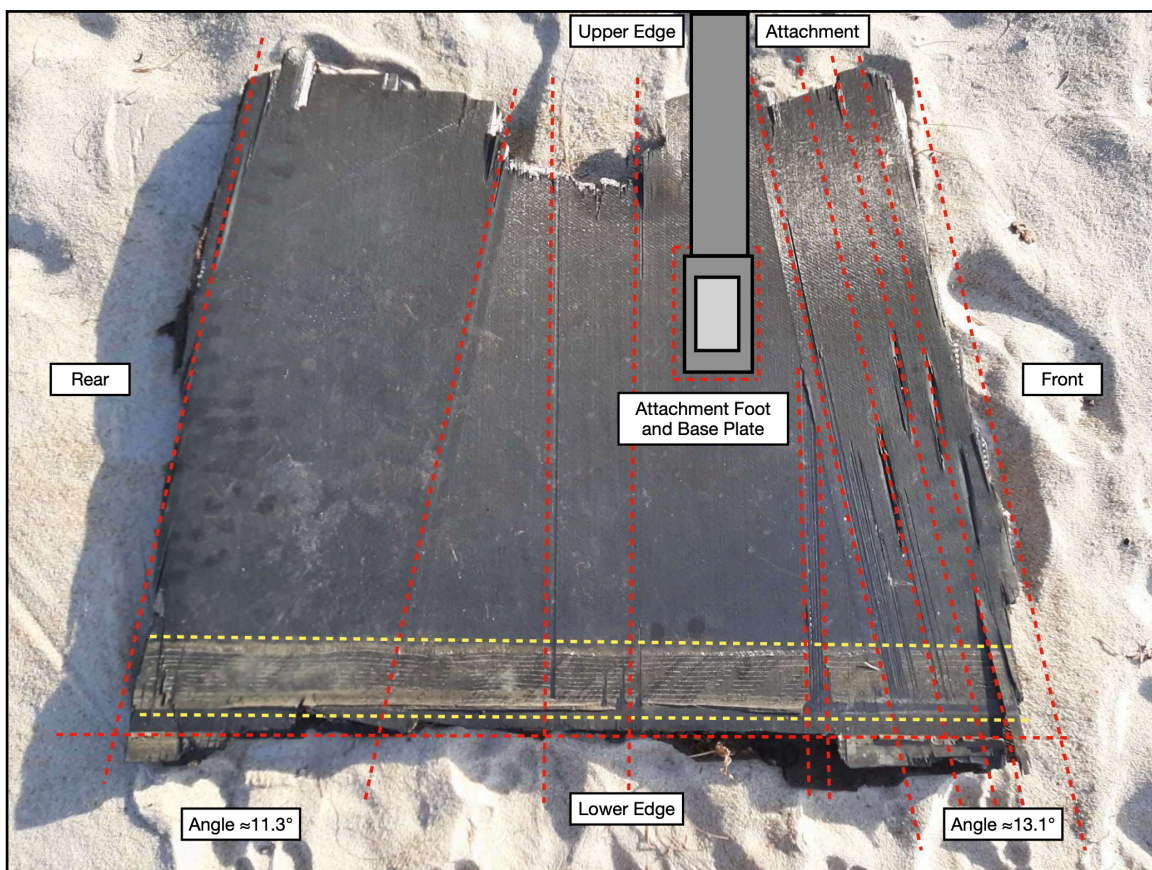
The debris item is fractured on all sides and is therefore smaller than the undamaged part in both length and width. The debris item has a middle section around the indent possibly made by the base plate connected to the attachment foot, which aligns with the attachment shown in the schematic in Figure 55 below. This middle section is perpendicular to the lower edge.

The debris item has a band along one edge marked in yellow in Figure 55 below and is likely the remnants of the back cover plate adhesive fixing on the lower bevelled edge.

The indent on the black side of the debris item is likely from the base plate of the attachment arm, which is located in a central position on the undamaged part. This implies that a larger part of the front edge is missing than the rear edge.

There is a slightly larger angle at the front of the trapezoid shaped debris item at $\approx 13.1^\circ$ as opposed to $\approx 11.3^\circ$ at the rear, which aligns with the overall trapezoid shape of the undamaged part.

The slicing damage is at the front of the debris, which is in the vicinity of the engine. It is possible that a part of the front or leading edge of the debris item was sliced off completely.

The debris item is likely the remnant of the left main landing gear trunnion door, which has been fractured on all sides (upper, lower, front and rear).

Figure 55: Debris Aircraft Position and Orientation Schematic.
