## Royal Commission on the Pike River Coal Mine Tragedy

# Volume 2

+ Part 1: What happened at Pike River

Date of Publication: October 2012

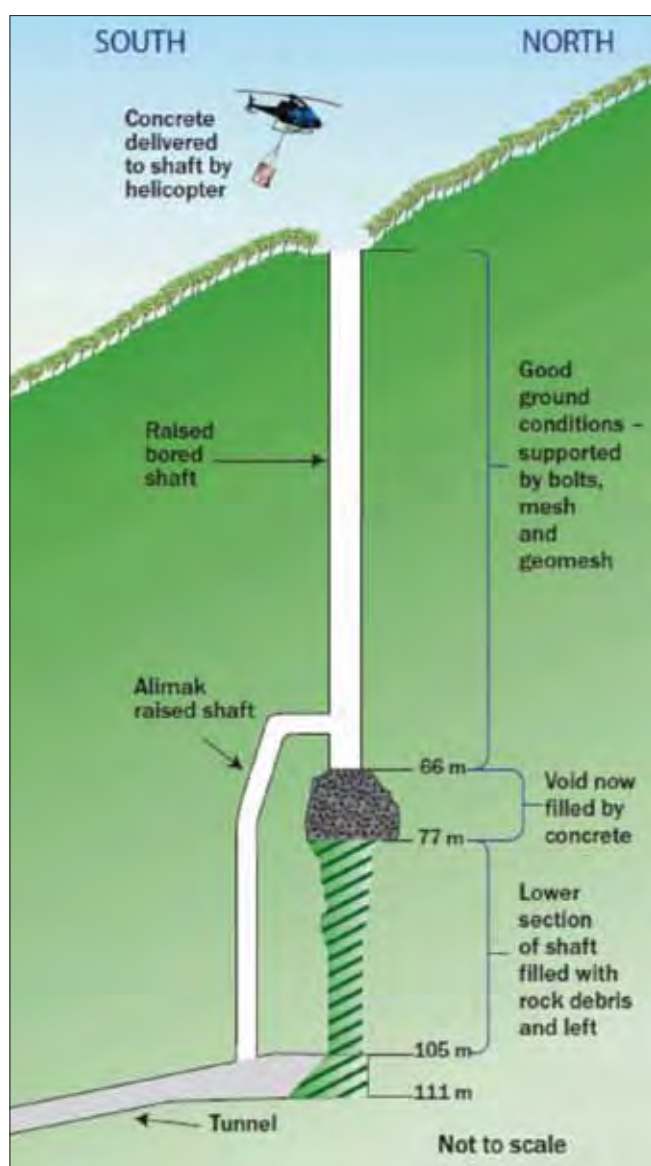
<sup>223</sup> Craig Smith, transcript, p. 3474.

49. Following investigation the company decided to abandon the bottom 35m, cap it with concrete and construct a bypass to reconnect to the upper 70m of the shaft, as shown in the diagram.

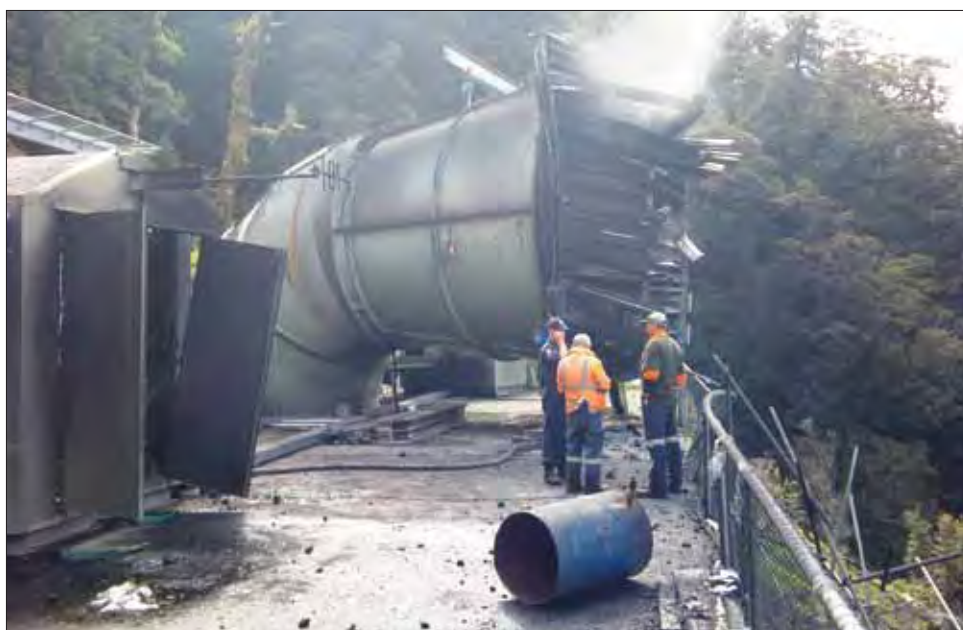
Figure 8.10: The surface fan after the first explosion

82. The surface fan failed in its vital back-up role. As shown in the photograph below, the explosion panels failed to divert the explosive air flow and debris from the first explosion, which damaged the fan, fan housing, shaft access doors, power generator and control infrastructure. Subsequent explosions propelled the fan and housing from their fixed positions.<sup>118</sup>

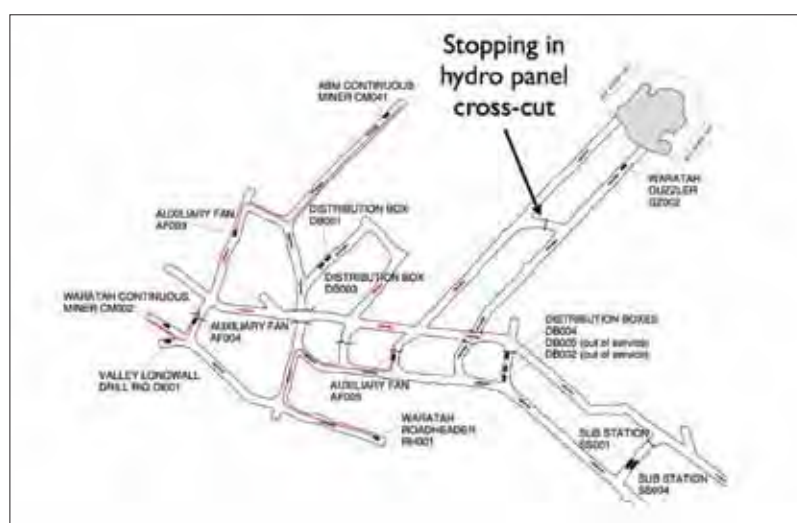
Figure 8.14: Stopping in hydro panel cross-cut<sup>165</sup>

116. On 30 October 2010 there was a large roof fall in the goaf in the hydro panel. The roof fall generated a pressure wave that knocked over the stopping at cross-cut one in the hydro panel, marked in the diagram below.

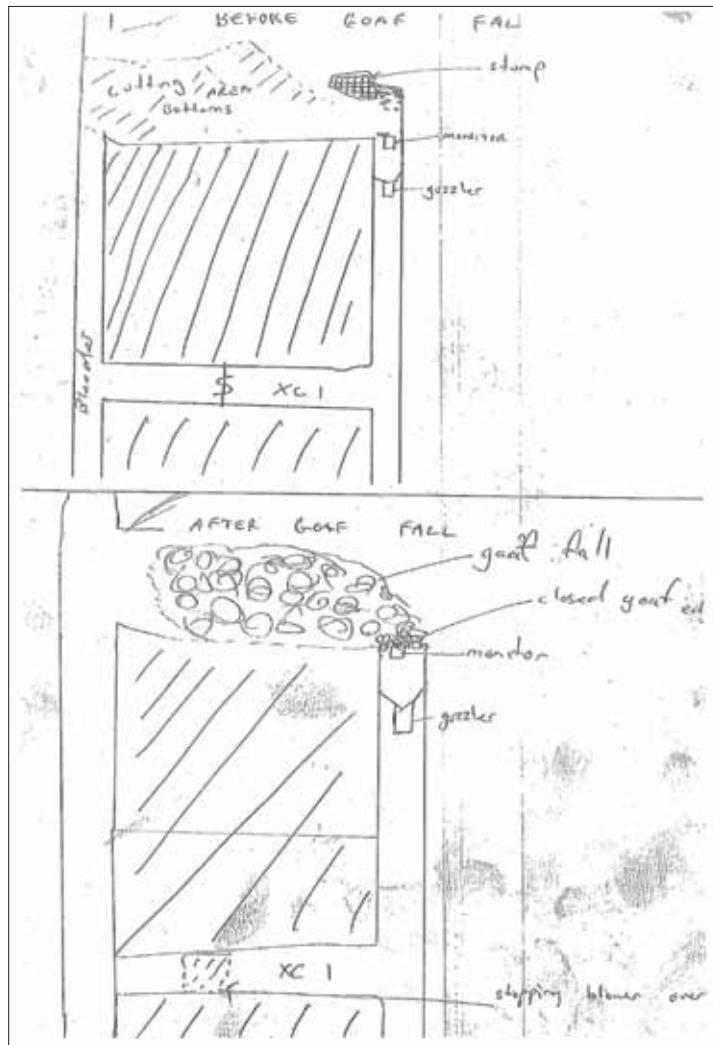
Figure 8.15: Effects of roof fall on 30 October 2010<sup>171</sup>

119. Mr Wylie completed an incident report.<sup>170</sup> He attached a hand-drawn diagram showing the effects of the roof fall, including the blocked heading at the entry to the goaf and the damaged stopping in cross-cut one, with the words 'stopping blown over'.

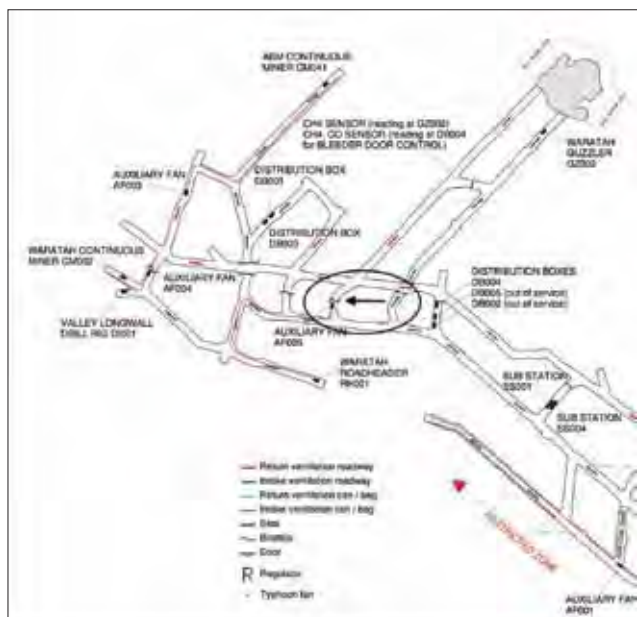
Figure 8.16: Hydro panel and cross-cut 3<sup>184</sup>

126. The DOL investigation stressed the significance of the stopping at cross-cut 3, marked with an arrow below.

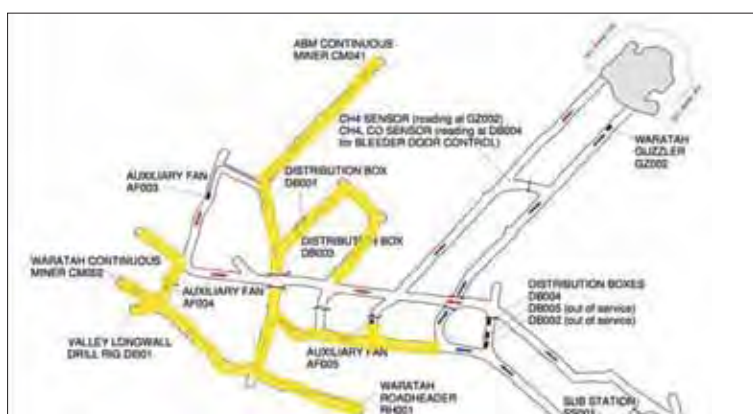
Figure 8.17: Ventilation inbye of the monitor panel<sup>198</sup>

135. Ventilation inbye of the monitor panel was particularly fragile and struggling to cope with the extent of mining operations and gas load in the mine.<sup>197</sup> Those areas had a small amount of pressure (14Pa) and quantity (49m<sup>3</sup>/s) available to ventilate the three working places and two standing places inbye of panel 1. That area is shaded yellow in the following diagram.

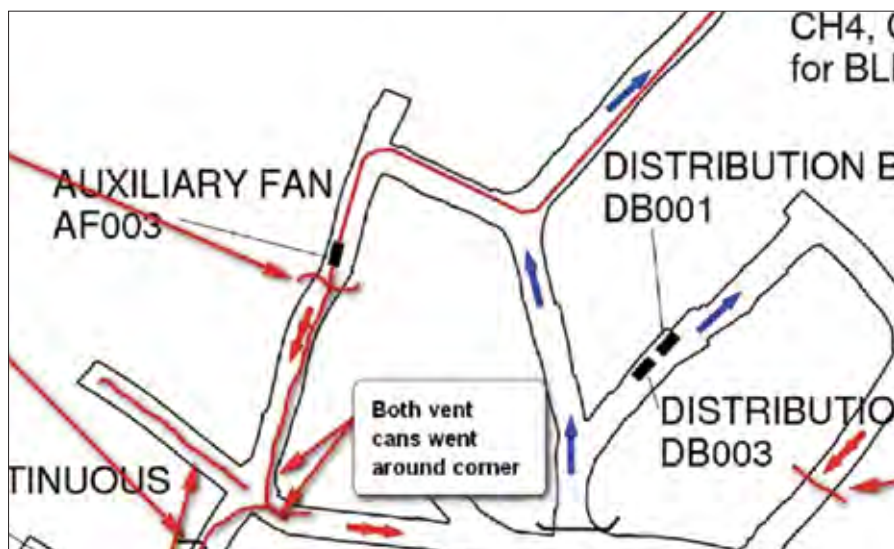
Figure 8.18: Location of the auxiliary fan<sup>201</sup>

136. DOL concluded that, given the gas make in the mine and the number of faces being worked, it should have been apparent that the ventilation system was stretched to its limit. Pike's approach allowed no factor of safety to deal with predictable hazards.<sup>199</sup>
137. Mr Reece also noted other deficiencies with the ventilation system, for example, the placement of an auxiliary fan (AF003) immediately next to a stopping,<sup>200</sup> which meant the fan did not have the necessary 30% of fresh air passing over it to ensure it did not overheat. The fan can be seen towards the left-hand side of the following diagram.

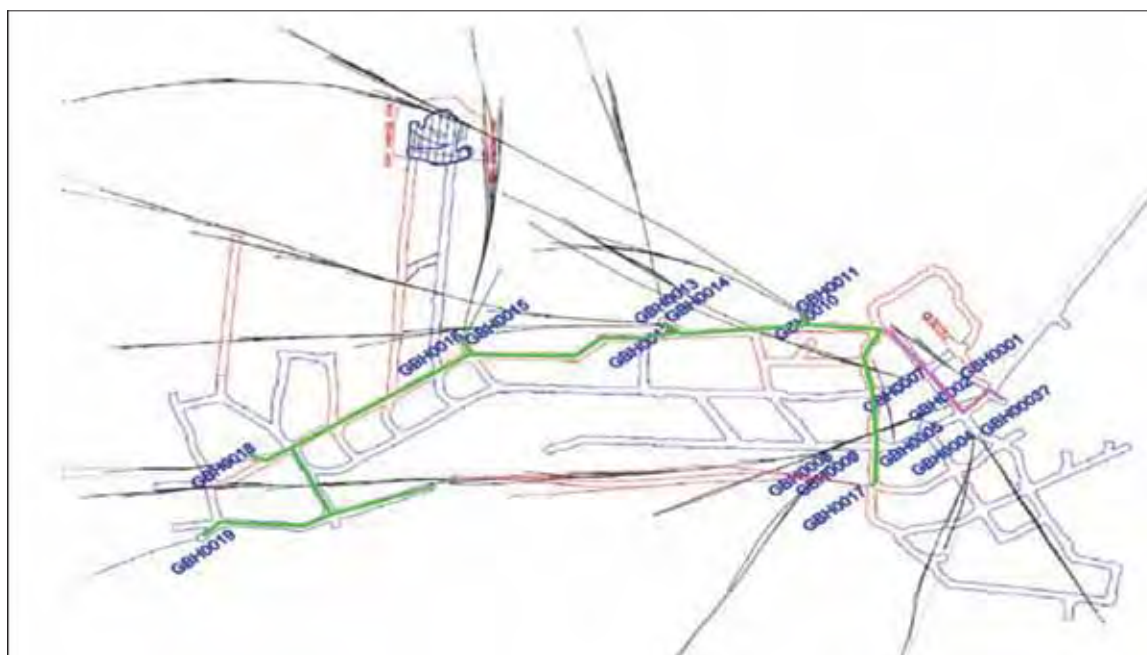
Figure 9.7: Gas drainage line and in-seam boreholes<sup>67</sup>

70. The pipeline was installed primarily in the return airways leading from connected boreholes outbye to the riser (as shown below in green), but it also ran for about 100m in the intake airway (shown in pink) from the overcast near the underground fan through Spaghetti Junction before turning left and then right to the gas riser located at the entrance to the slimline shaft/FAB. This created a significant hazard.
