Hydro-panel sensors

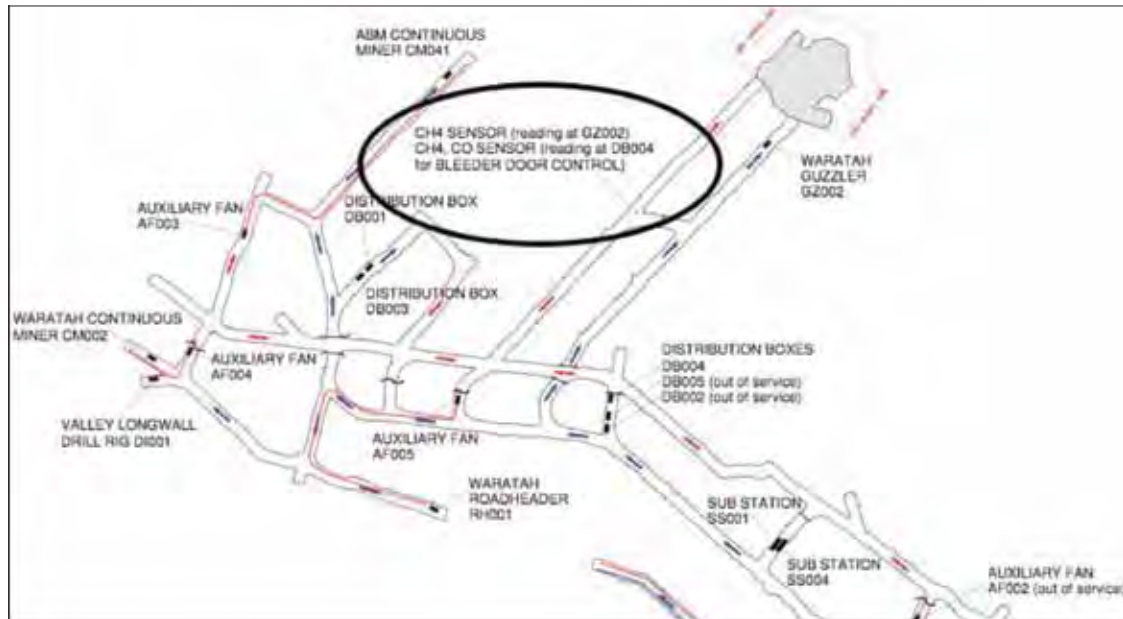
Figure 10.3: Location of hydro-panel sensors²⁹

17. There were two methane sensors located in the return from the hydro panel, circled in black on the diagram below.

18. One provided a reading at the guzzler near the hydro monitor, but did not report to the surface or result in any permanent record of gas levels. The other sensor had been exposed to methane concentrations above 5%, and did not work after 13 October 2010.³⁰

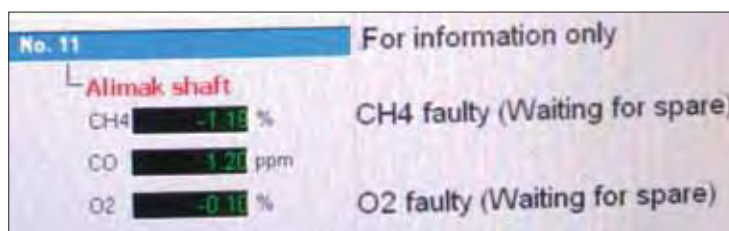
Figure 10.4: Control room operator's screen on the Safegas system³²

19. There were several problems with the gas sensors in the ventilation shaft. First, the sensor at the bottom of the ventilation shaft stopped working on 4 September 2010, nearly 11 weeks before the explosion, and was never repaired or replaced.³¹ Indeed, the control room operator's screen on the Safegas system was permanently annotated to say the sensor was 'faulty' and 'waiting for spare'.

20. Mr White was not aware the sensor was not working and could not explain why the sensor was broken for two and a half months without his knowledge.³³ The problem appears to have been discussed at the review of the surface fan failure on 7 October 2010, at which Mr White was present.³⁴ It was resolved to 'Set up Gas Monitoring [at] shaft bottom',³⁵ but was still to be done at the time of the explosion.

21. With the bottom sensor broken, there was just one sensor in the return reporting to the surface. The expert panel described this situation as 'hard to comprehend' in a gassy mine.³⁶

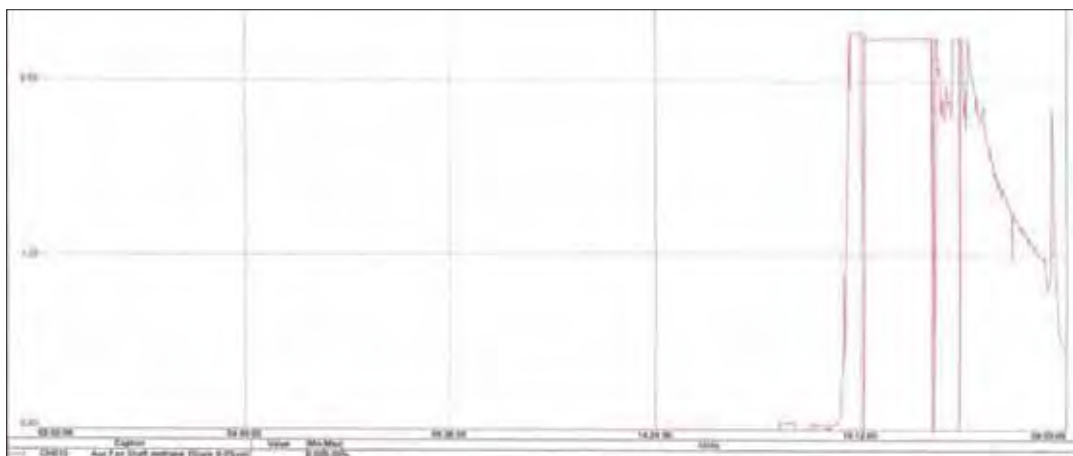
Figure 10.5: Auxiliary fan shaft methane – 6 October 2010⁴³

24. The ventilation shaft sensor also 'latched' or was poisoned on a number of occasions, causing a flat line to show on the surface controller's system. The flat line phenomenon indicated the sensor had been exposed to greater than 5% methane. This occurred during the 'gassing out' of the mine on Wednesday 6 October 2010, after the failure of the surface fan.

25. There was no data from the sensor from the time of the fan failure on 5 October. The control room system then showed a flat line around 2.5% during the evening of 6 October. Despite a review and a notification to the Department of Labour (DOL) about the incident, nothing was done about the flat line issue.
26. There was then a second flat line that started late on Thursday 7 October and continued through to Friday 8 October 2010 during the degassing procedures.

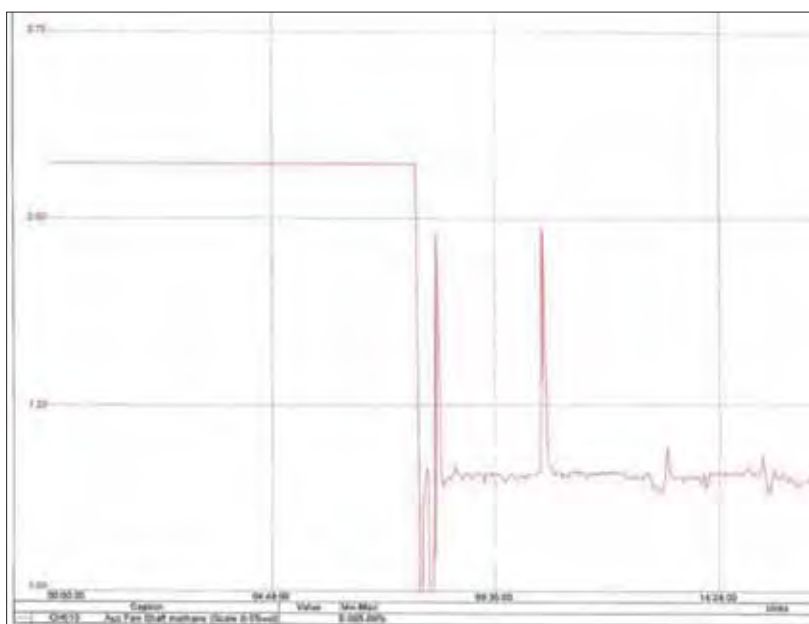
Figure 10.6: Auxiliary fan shaft methane – 8 October 2010⁴⁴

27. Mr White told the commission he was not aware of any flat lines, and if he had been, it would have been a cause for investigation.⁴⁵ However, he accepted that he signed a ventilation survey dated 7 October 2010 that said in red capital letters 'Had a spike of 2.8% at vent shaft – monitor stuck on this reading.'⁴⁶
28. Third, while the sensor at the bottom of the shaft was operational, there was an obvious discrepancy between the readings at the top and bottom of the shaft. The discrepancy is shown in the following graph prepared by DOL, which shows the reading from the top of the shaft in red, and the reading from the bottom of the shaft in blue.

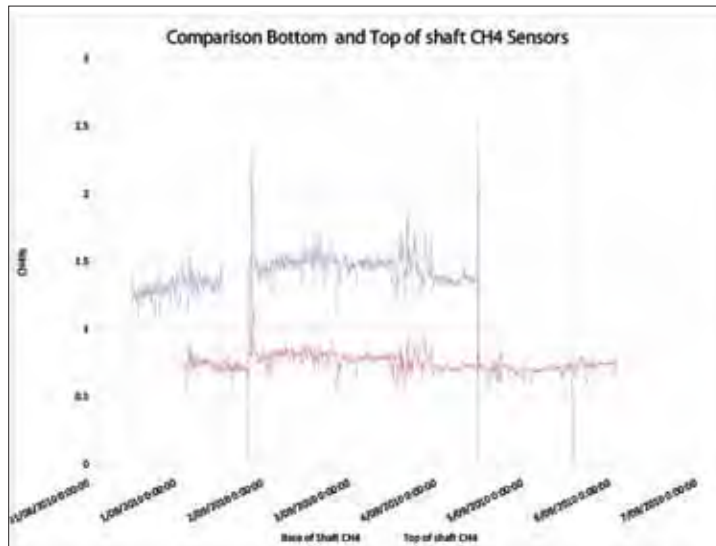
Figure 10.7: Comparison bottom and top of shaft CH₄ sensors⁴⁷

29. There was an obvious question to be answered given that two sensors in the same air stream were reading so differently.⁴⁸ The discrepancy was not investigated.⁴⁹

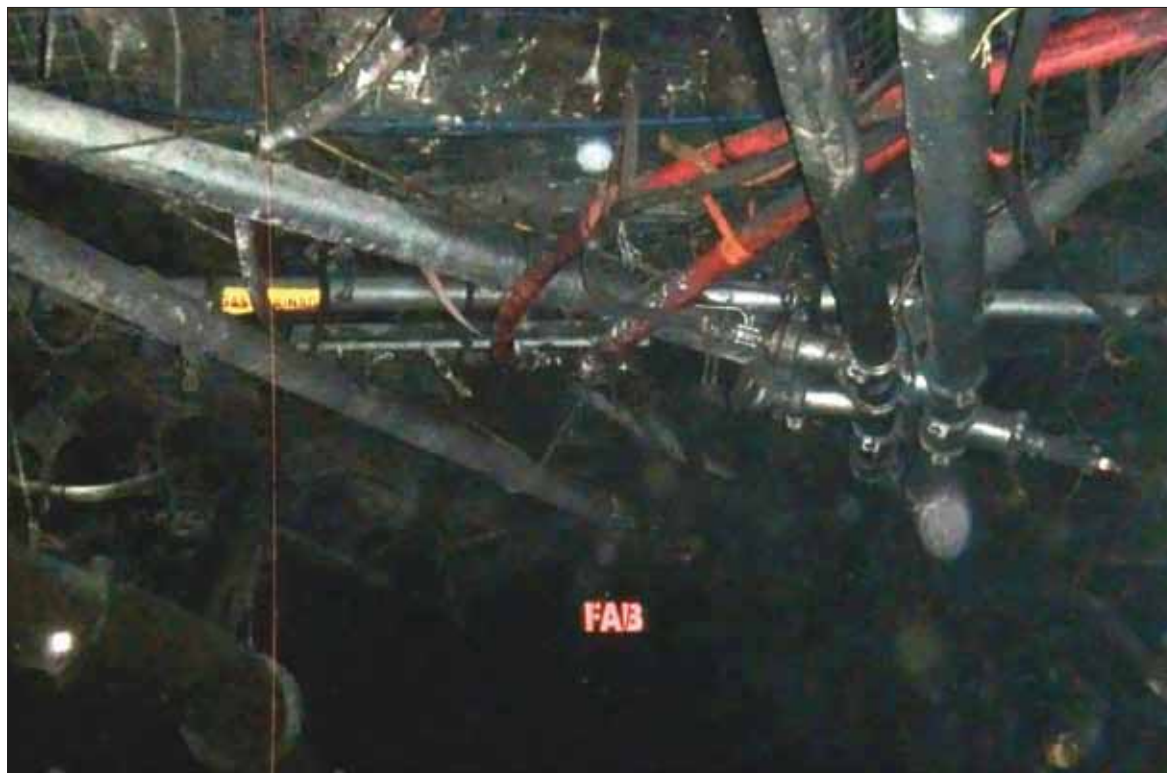
Figure 11.2: Spaghetti Junction¹⁸

23. The inclusion of pit bottom south and Spaghetti Junction in the non-restricted zone led to another hazard. These areas contained roadways and significant utility services – water pipes, compressed air pipes and gas drainage pipes. To those were added 11kV lines. The sheer quantity, and lack of separation, of utility services at Spaghetti Junction is shown in Figure 11.2. The high-voltage cables are red.

24. Of that configuration mining consultant David Reece said:
- This is quite unusual to have pipes like this, this sort of configuration in a mining situation. The other thing is the high-tension cables that are also interspersed with all these services in that particular area. So this is potentially an area where these could be hit by a diesel vehicle or something of that nature ... it's certainly hazardous and the combination of services that you've got there with high-tension cables, and we're talking about 11,000 volts in those cables, if you damaged that at the same time as the pipeline, it is highly likely that you would get an ignition at that point.*¹⁷

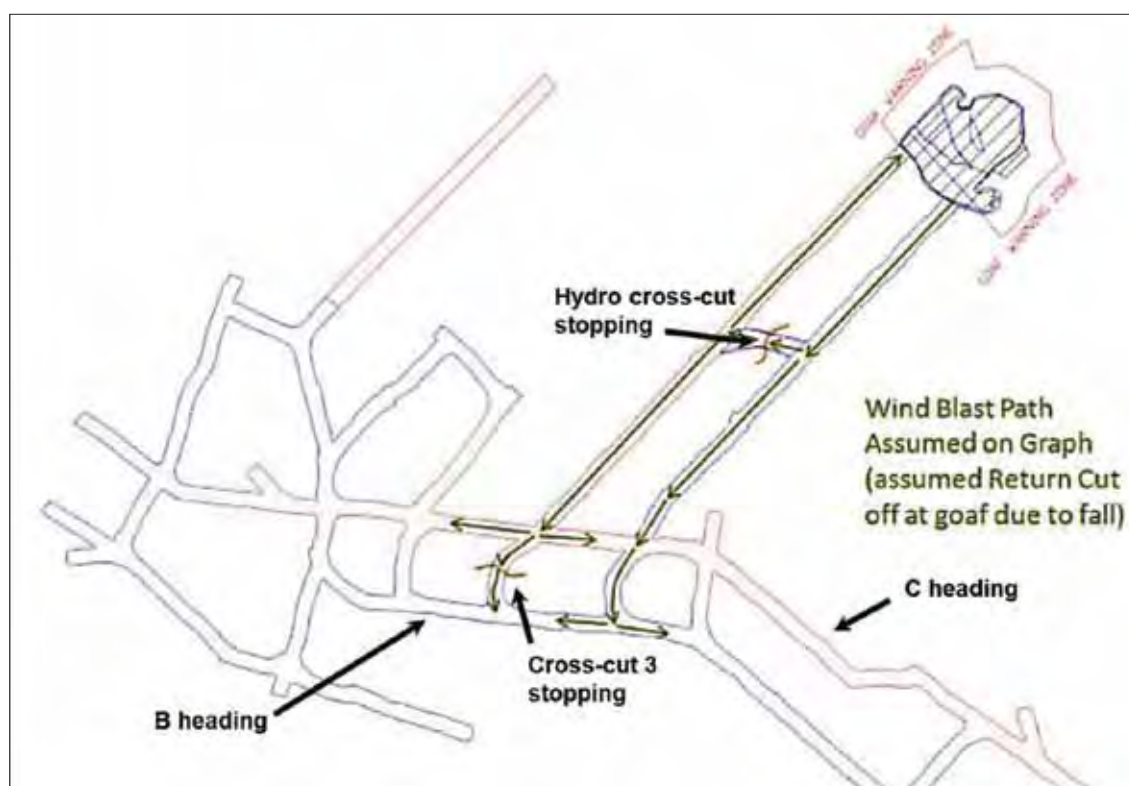
Figure 14.3: Gas flow path due to goaf fall²⁰

38. The expert panel suggested three potential ways in which an explosive atmosphere of between 5 and 15% methane in air may have formed to become the fuel source consumed in the explosion. Scenarios one and two implicated the goaf, with methane emitted by a goaf fall as the initiating event, but with different transmission paths outside the hydro panel as the methane was diluted to within the explosive range. The difference between these scenarios was one of degree. The third scenario, however, envisaged a layered accumulation of methane in the western working areas of the mine.
39. Scenarios one and two are best explained by reference to the following diagram.

40. The expert panel assumed that the return roadway from the hydro panel (left side of the diagram) would have been 'cut off at the goaf due to (the roof) fall'. Hence, the diagram depicts only methane expelled along the intake roadway (right side of the diagram) as far as B heading, and then flowing both inbye and outbye. In addition, it was thought that methane would be forced into the hydro panel cross-cut, would breach the stopping in this cross-cut

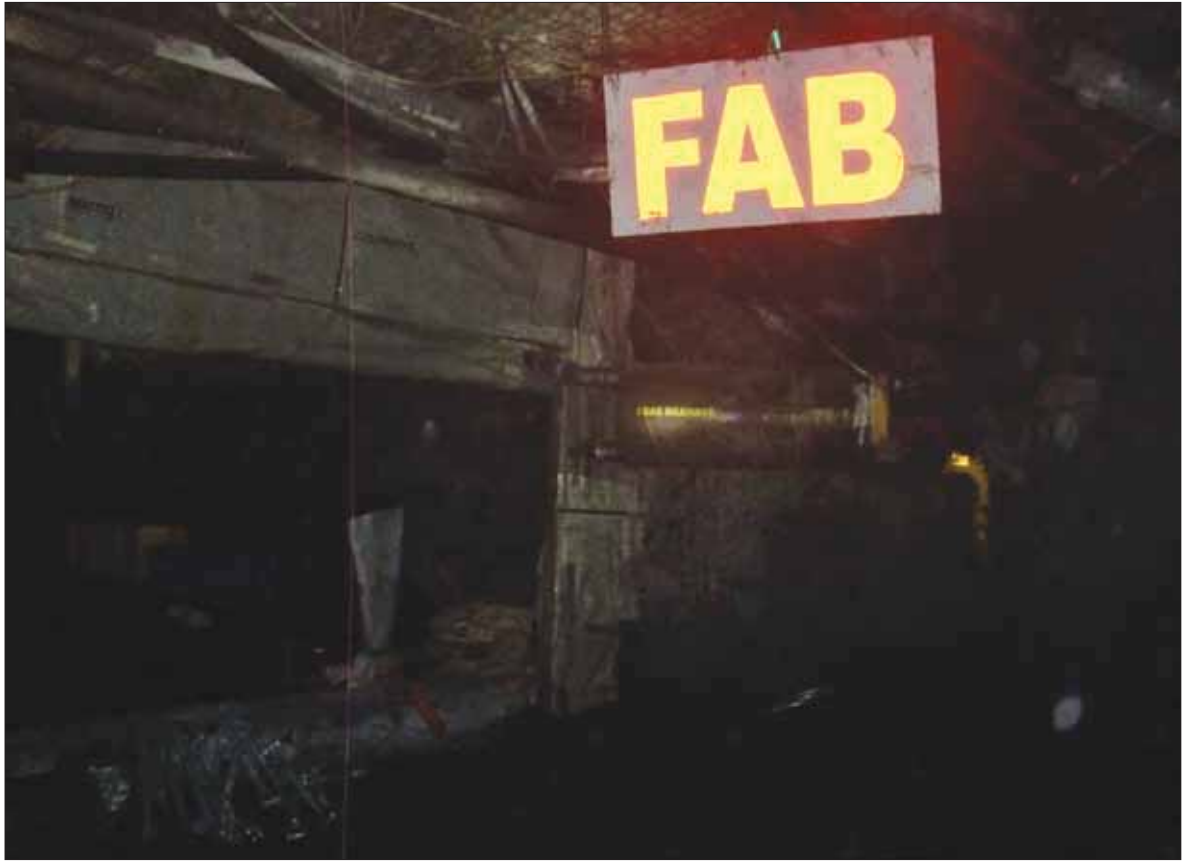
Figure 16.2: View of the upper FAB from outside⁷⁸

133. The roll-down brattice screen would not have prevented the FAB being polluted with the toxic atmosphere. Following the explosion, the failure of the underground fan resulted in a reversal of the air circuit, meaning the slimline shaft became a chimney through which noxious explosion products were drawn into the stub and up to the surface. The upper FAB was not a place of safety and was not functional as an FAB at 19 November 2010. It was not even fit as a changeover station.
