Debris Analysis - Main Landing Gear Trunnion Door Panel

by Blaine Gibson and Richard Godfrey

12th December 2022

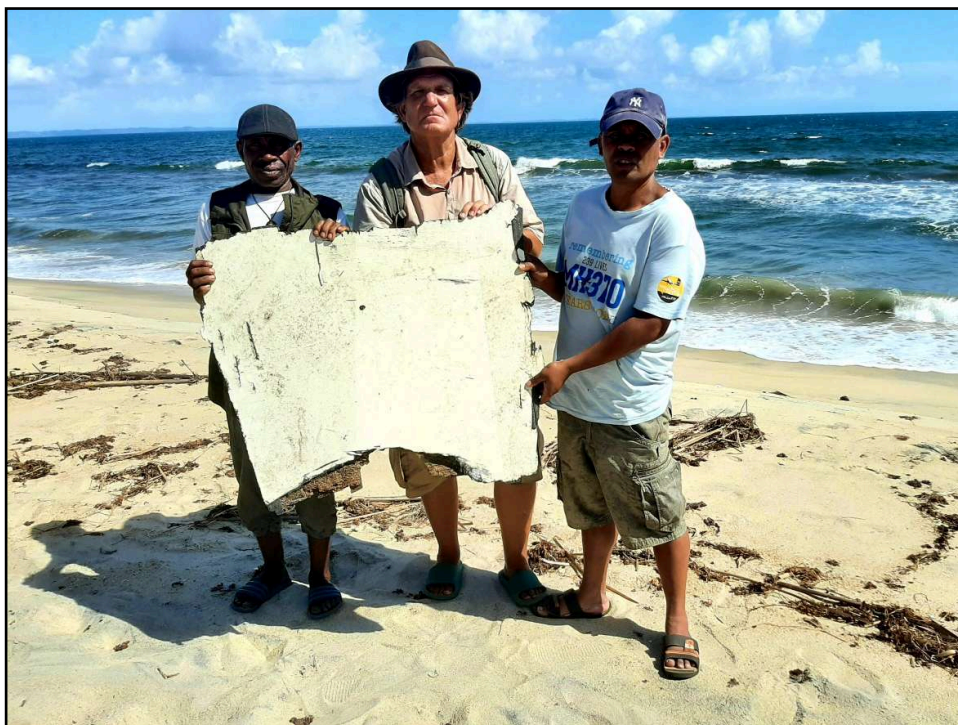
Figure 1: Blaine Gibson and finders of the debris item.

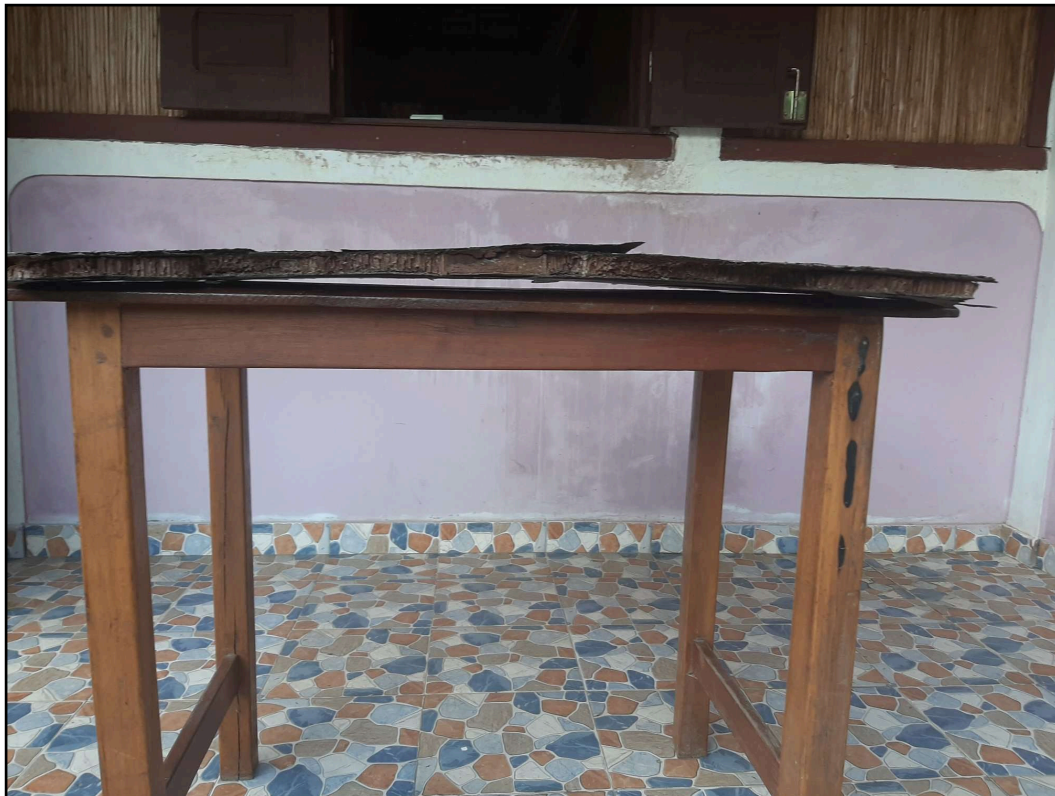
The white side is slightly convex, the black side is slightly concave.

Figure 11: Debris Item Side View.

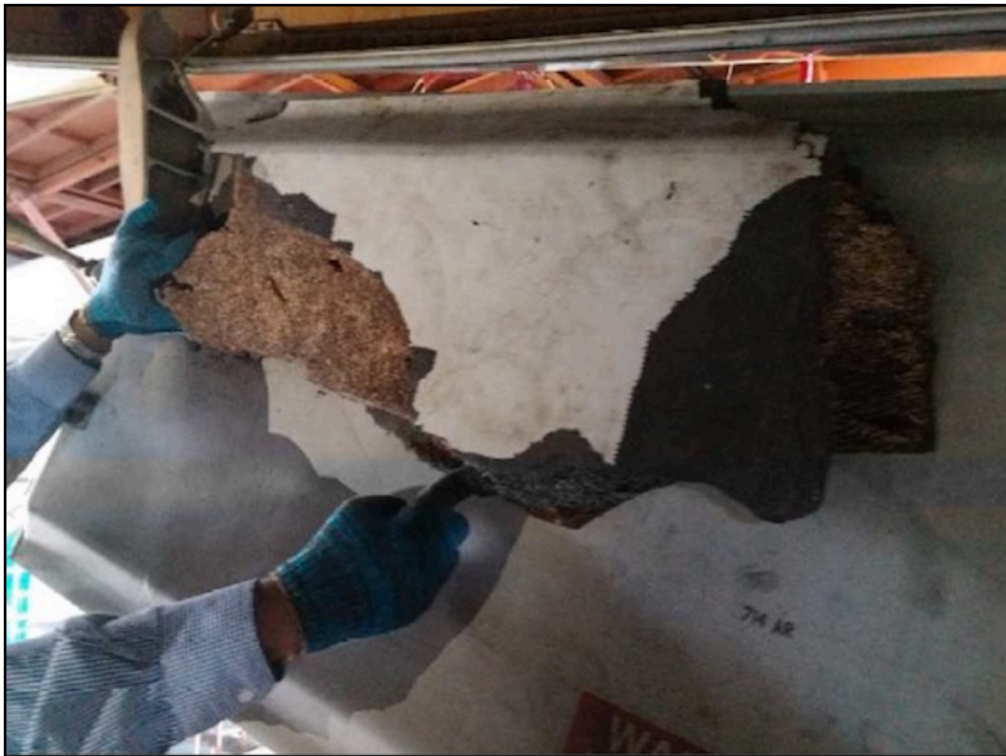
The debris item is similar in construction to the part of the right nose landing gear door which was also found on Antsiraka Beach, Madagascar. The nose wheel door debris also shows tension damage and partial delamination or debonding.

Figure 35: Nose Wheel Door Debris found 12th June 2016 in Antsiraka Beach, Madagascar.

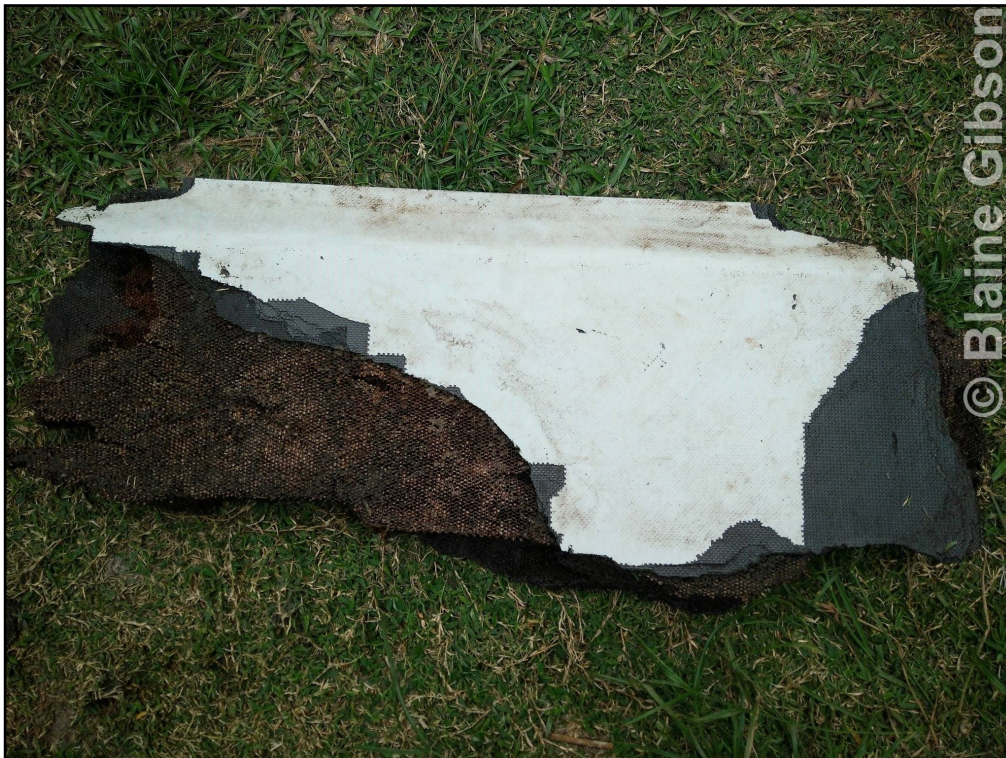
Figure 36: Nose Wheel Door Debris showing tension damage and partial delamination.

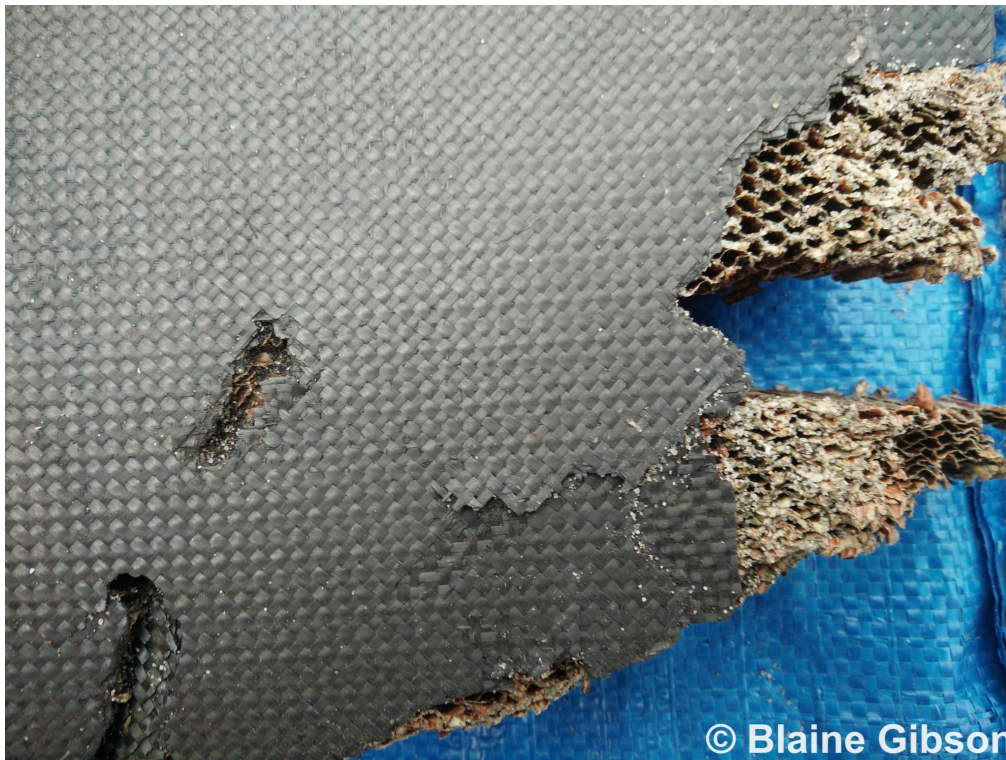
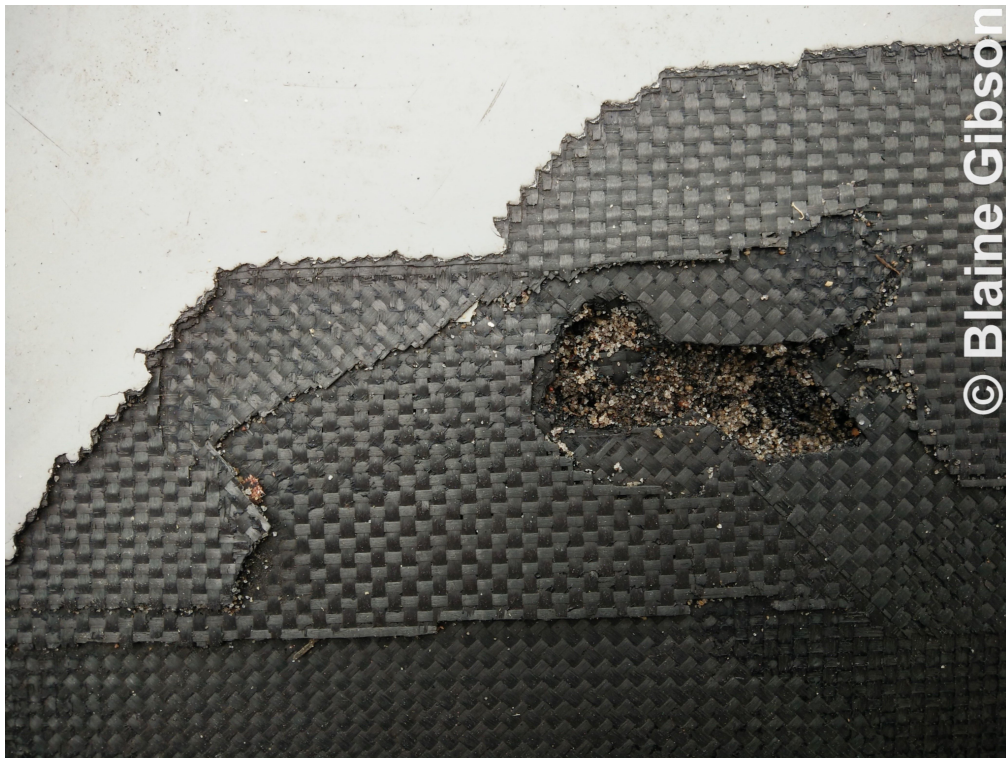
The debris item also shows puncture and compression damage similar to the damage to the nose wheel door.

Figure 37: Nose Wheel Door Debris showing puncture damage.

Figure 38: Nose Wheel Door Debris showing puncture damage.

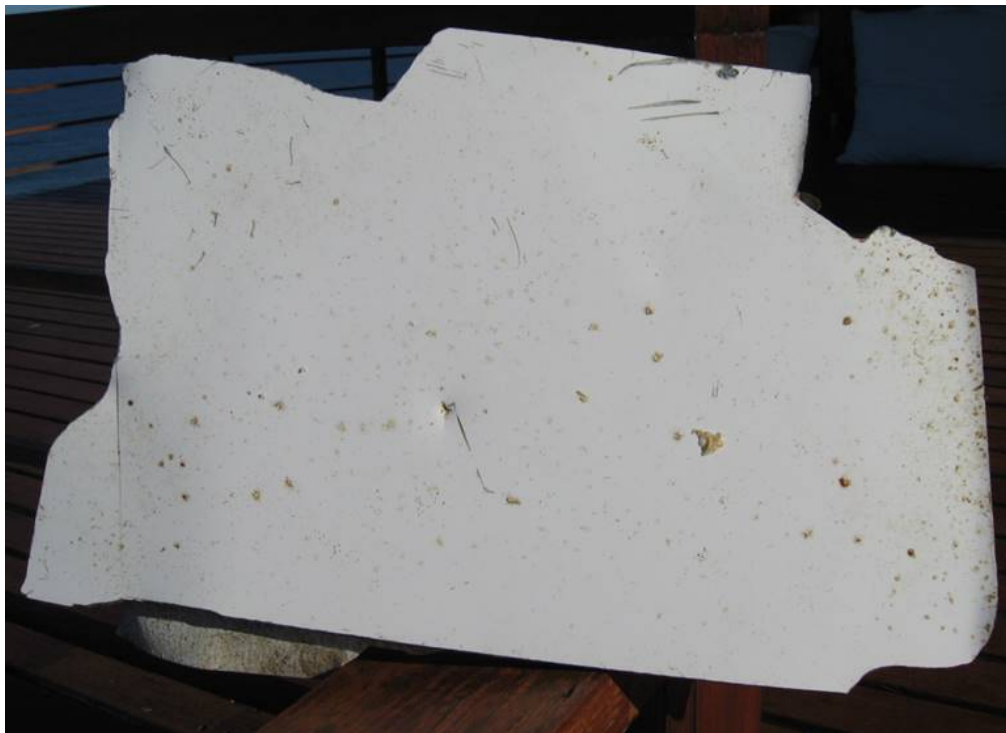
The debris item shows cuts, scratches, pits and partial delamination similar to the panel found on 19th August 2016 in Praia de Rocha, Mozambique by Barry McQuade.

Figure 39: Panel Debris showing cuts, scratches and pitting damage.

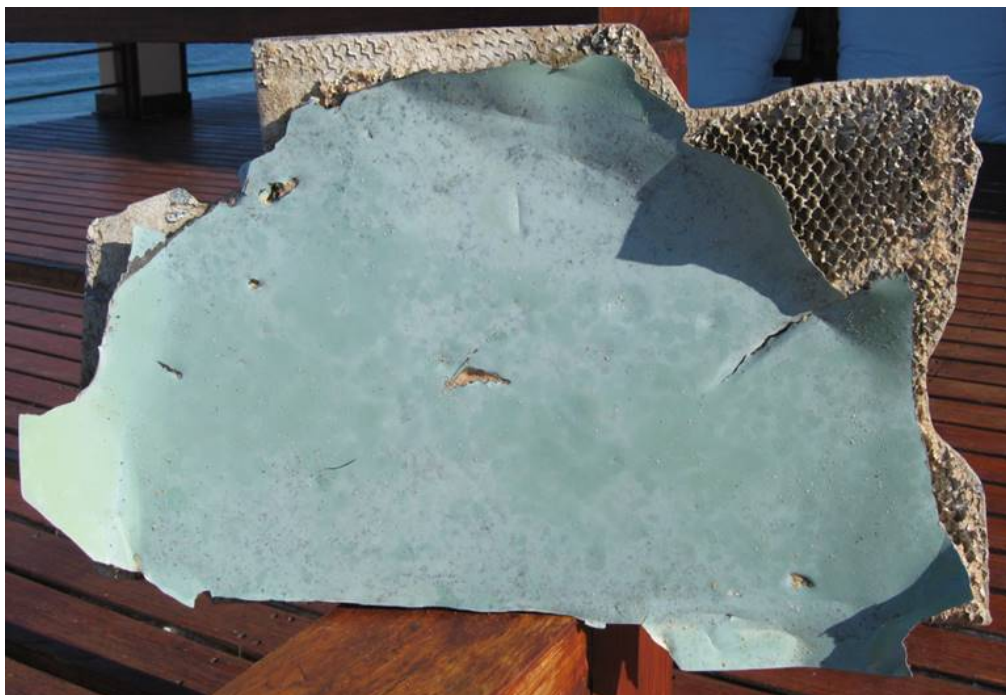
Figure 40: Panel Debris showing partial delamination.

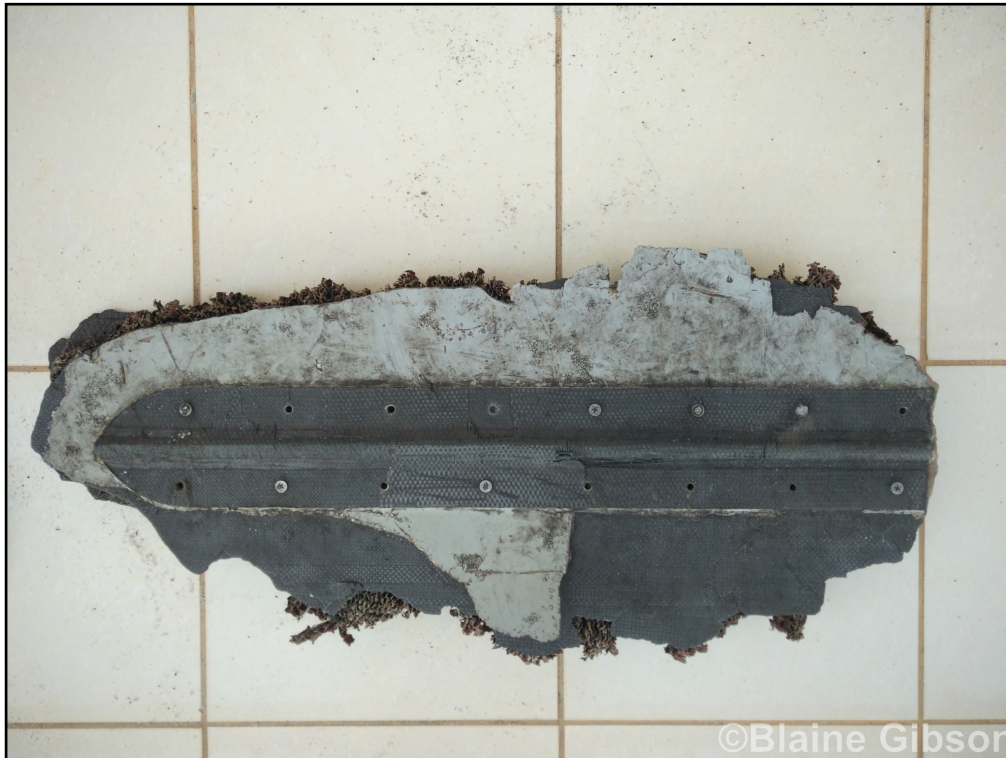
The debris item shows possible delamination of the white upper coating revealing the black next layer similar to the right engine inner side vortex generator rear part found on 1st September 2016 in Maroantsetra Beach, Antongila Bay, Madagascar by local fishermen and handed to Blaine Gibson.

Figure 41: Vortex Generator showing partial delamination.

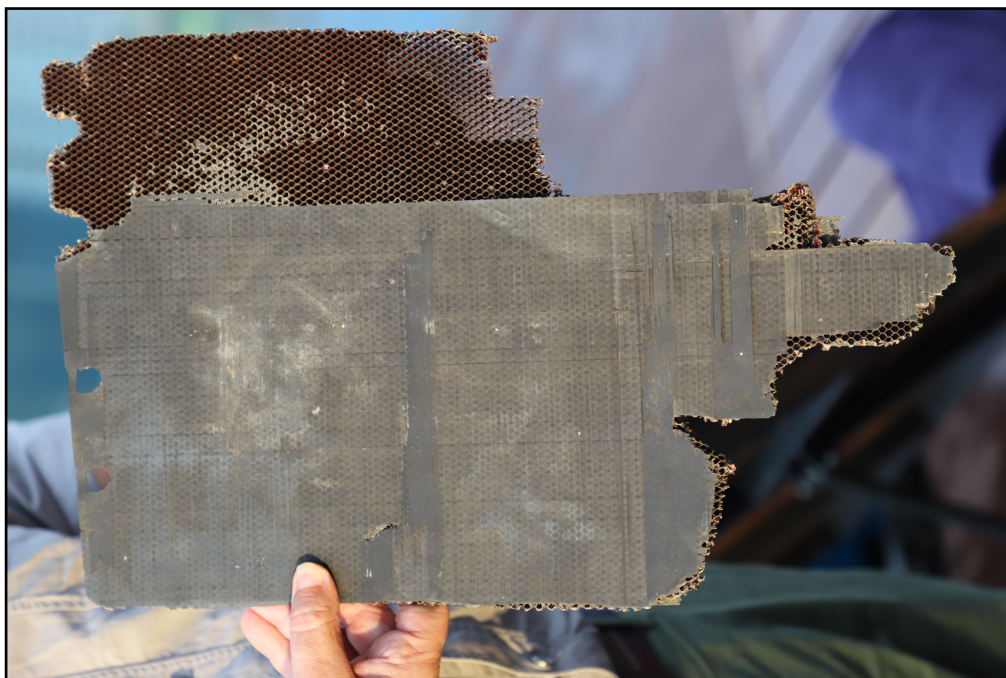
When the black layer is removed the honeycomb is revealed as shown in Figure 41 on another item of debris found in Madagascar in 2016.

Figure 42: Black covering layered on top of honeycomb.

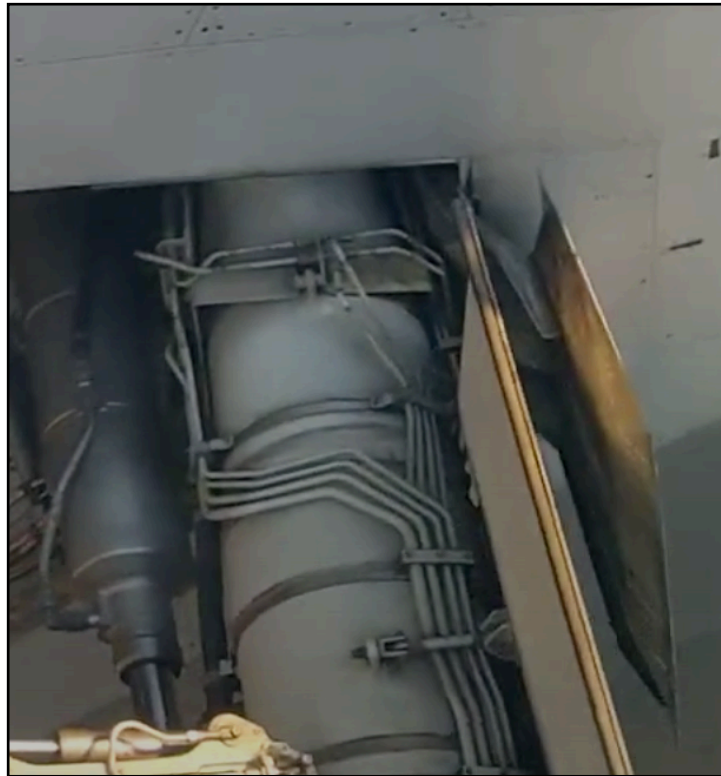
The trunnion door has a back cover plate with a single fixing. No hinge fitting or door latch is evident in Figure 50 below. If the cover plate was ripped off from the black side of the debris item leaving fracture damage on all four edges, then the impact force was considerable. The attachment shown in Figure 22 is possibly the remnant of the back cover plate fixing at that point. The single rectangular indent shown in Figure 20 is a possible match for the base plate of the single fixing on the main landing gear trunnion door. The trunnion door is light weight.

Figure 50: Close Up Main Landing Gear Trunnion Door Right Wing.

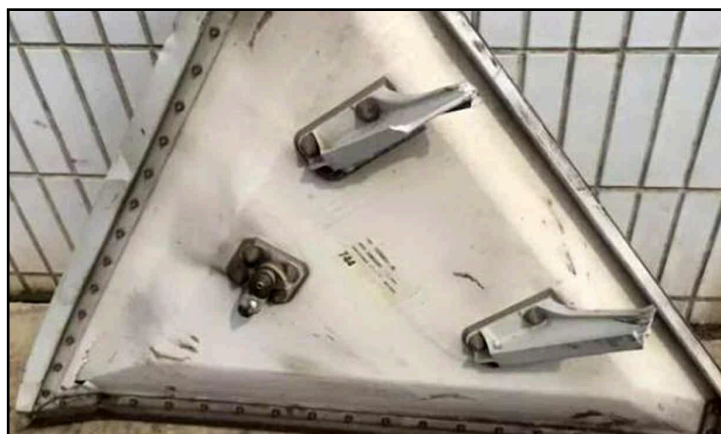
There is also a main landing gear triangular door shown in position in Figure 48, which has two fixings and a single drive rod base plate. The part is made of metal, which is designed to withstand the slip stream forces and weighs around 60 kg (132 lbs). The item shown below in Figure 51 fell off an Air France Boeing 777 shortly after departure from Shanghai airport.

Figure 51: Main Landing Gear Triangular Door.

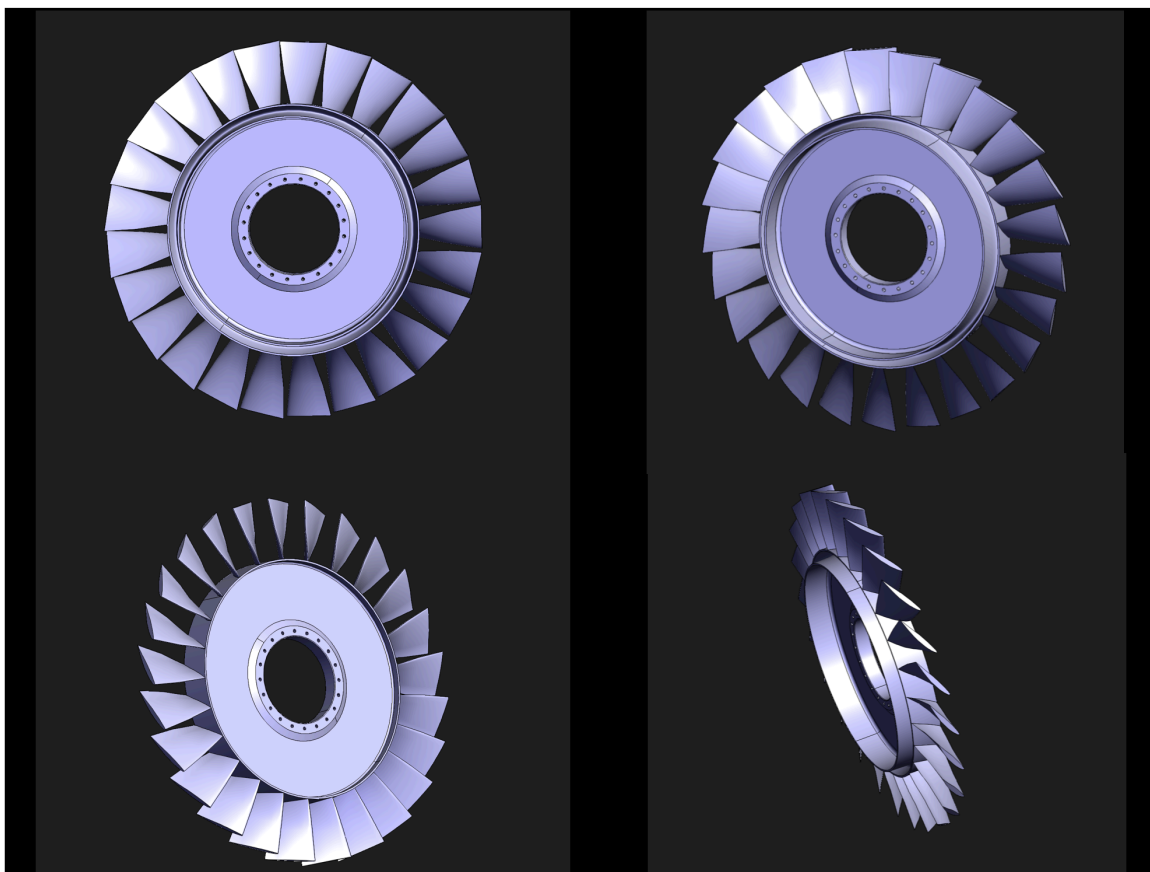
If an engine compressor ring penetrated the black side of the small door panel with considerable force on impact, then depending on the angle of impact, it is possible to cause the four parallel slices observed penetrating right through the debris item to the white side.

The fan blades are too wide and the turbine blades are too blunt, but the compressor blade rings range in width along the axis of the engine core from between 179 mm down to 96 mm (7.05" down to 3.78"). A compressor ring with a set of damaged blades of up to 4" in width fits the penetration observed in the debris item with slices of up to 4" long.

Figure 54: Rolls Royce Trent 892 Compressor ring with Blades.
