## Royal Commission on the Pike River Coal Mine Tragedy

# Volume 2

+ Part 1: What happened at Pike River

Date of Publication: October 2012

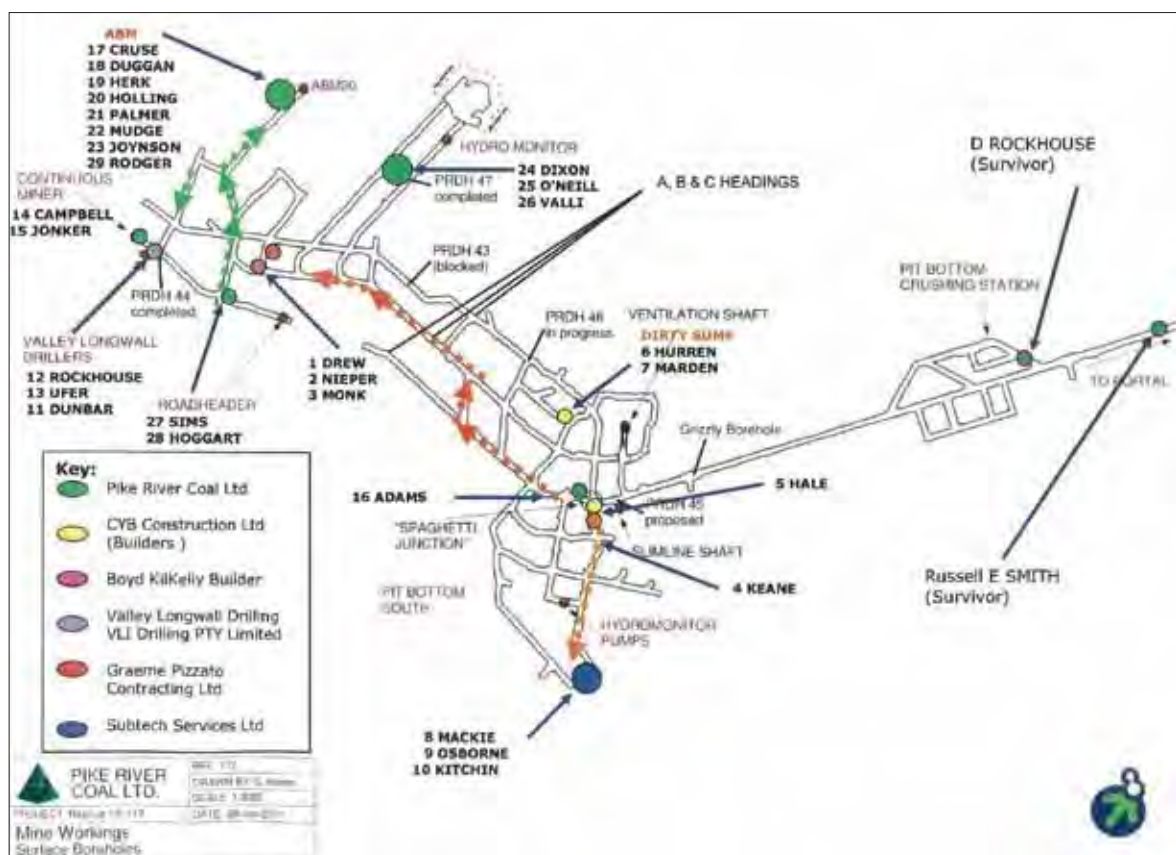
Figure 1.1: Last known position of the 29 deceased and two survivors<sup>2</sup>

6. The positions can only be indicative. They were fixed from the last sightings of the men by people who were also underground but left before the explosion, and also by reference to the work the men were to undertake that day.

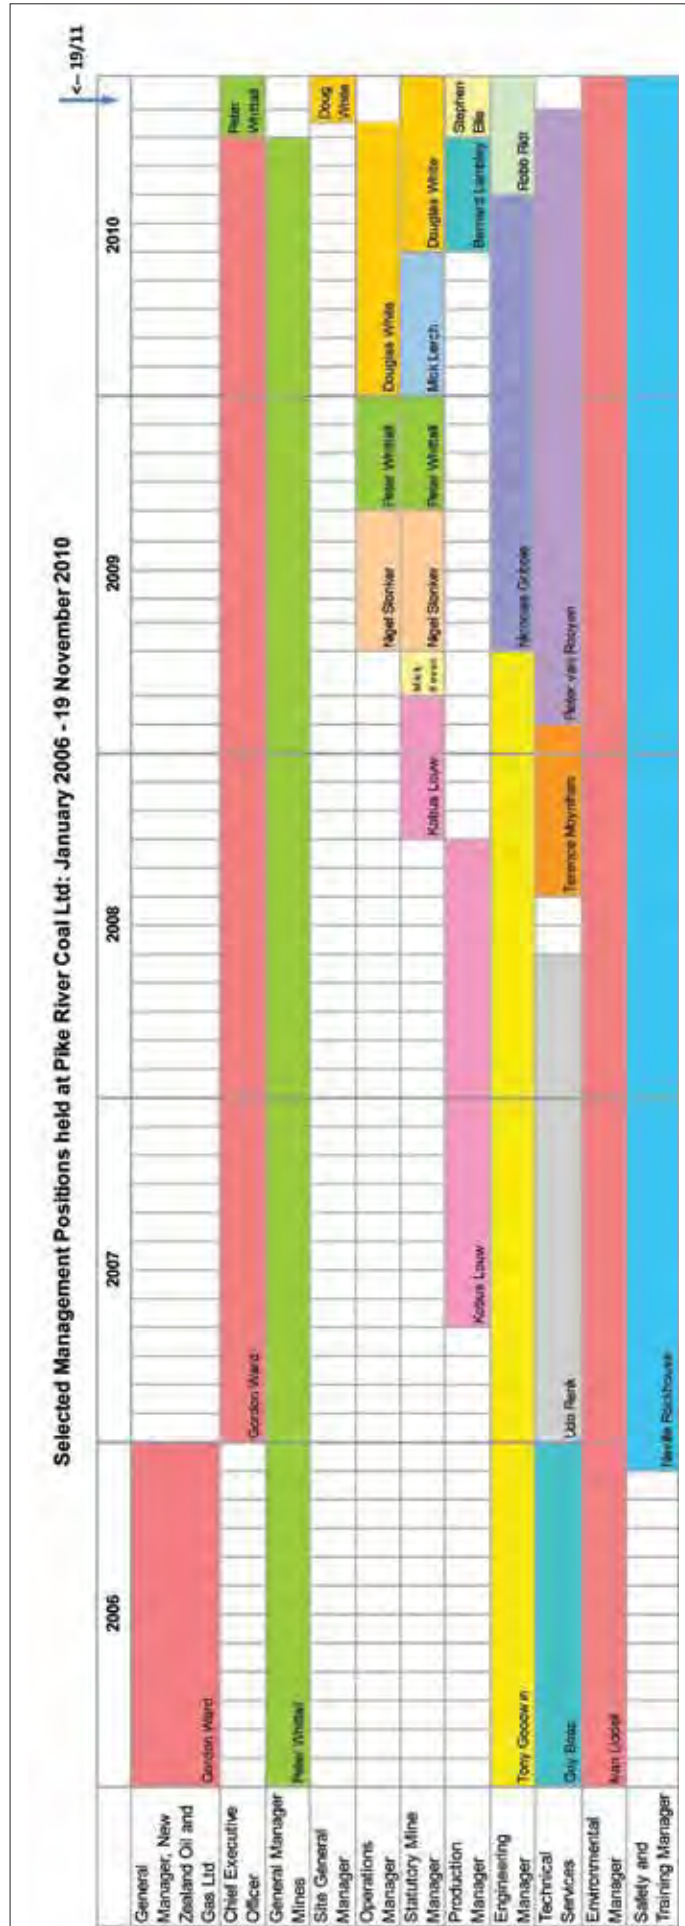
Figure 6.1: Selected management positions held at Pike River Coal Ltd, January 2006–19 November 2010<sup>9</sup>

5. Pike had a high turnover of miners underground,<sup>2</sup> and was unable to retain personnel in many key operational management roles.
6. As shown in Figure 6.1, from the time the mine was classified as a gassy coal mine in November 2008, Pike had six mine managers, two technical services managers and three engineering managers. In 2010 the mine had two production managers.
7. The high management turnover 'compromised [Pike's] functioning and continuity',<sup>3</sup> owing to inefficiencies, loss of institutional knowledge and the need for employees to adjust to differing management styles. There was no systematic handover process when staff changed; the exception was Pieter van Rooyen's handover when he left Pike in November 2010.<sup>4</sup>

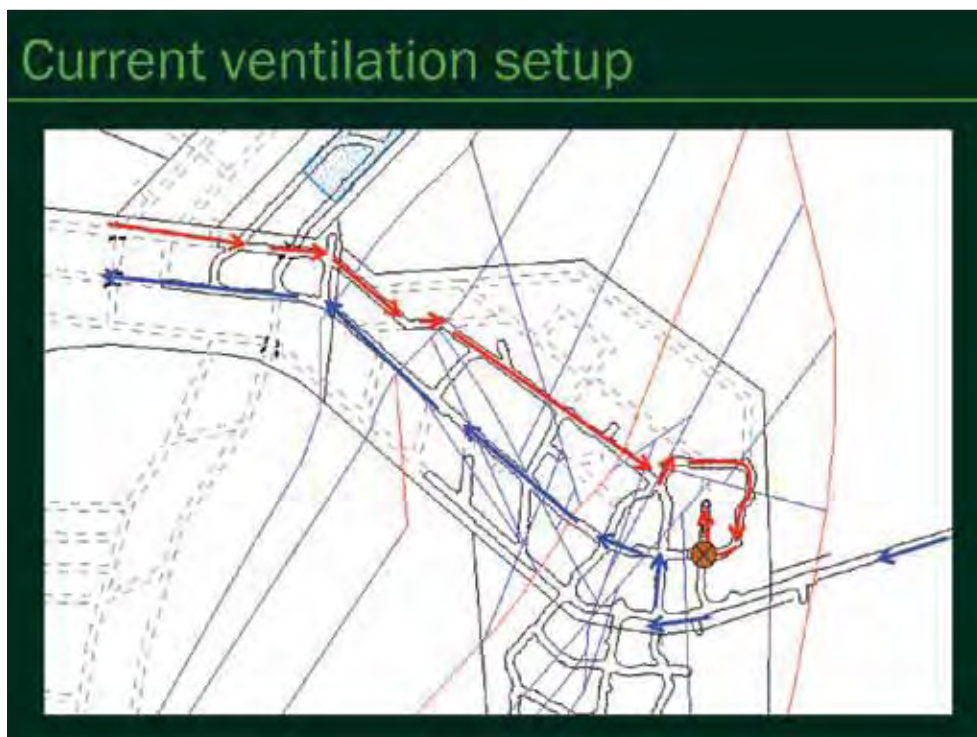
**Figure 8.4 : Current ventilation setup<sup>61</sup>**

46. Pike's early planning contemplated multiple intakes beyond the first year of development.<sup>60</sup> In November 2010 the Pike River ventilation system was still a one intake and one return system, as shown in the following diagram:

47. The blue arrows depict fresh air entering through the intake (main drift), circulating through the workings and exiting through the return, shown in red. The main underground fan is depicted as a circled X towards the bottom right of the diagram, at the base of the ventilation shaft. Mr van Rooyen presented this simplified diagram of the Pike ventilation system to the Pike board in August 2010.

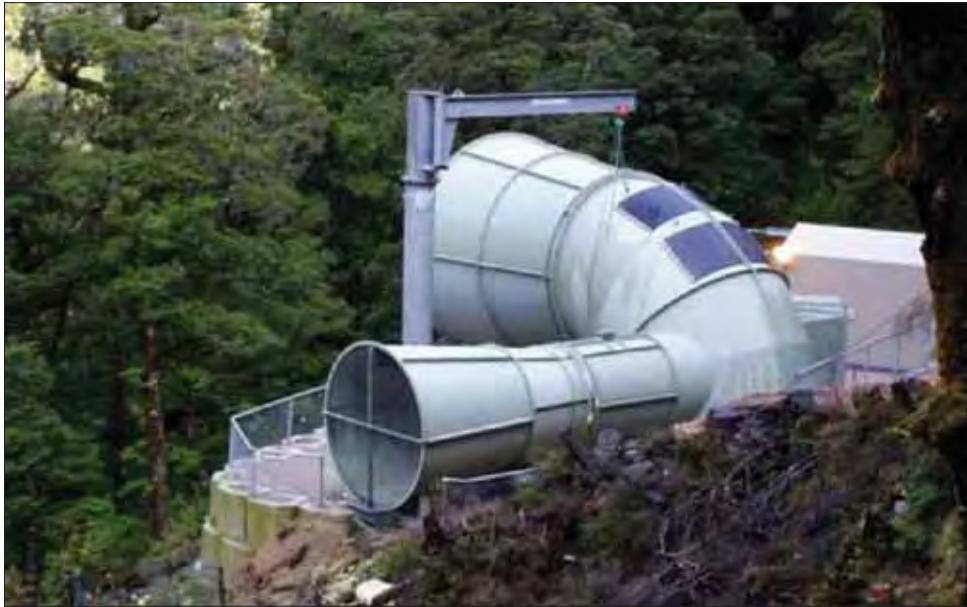
Figure 8.5: The surface back-up fan

50. Pike installed the surface back-up fan at the top of the ventilation shaft in June 2009. The exhaust structure (evasé) for the surface fan is on the left in the photograph, and the larger evasé is for the main underground fan.

51. Fläkt Woods designed, built and installed the surface fan. It was powered by a 132kW electric motor with a capacity of 90m<sup>3</sup>/s air flow at 0.4kPa (kilopascals) pressure.<sup>66</sup> The fan acted as the primary fan until the first main fan was commissioned underground.
52. The diagram below shows a bird's-eye view of the surface fan as installed. In the centre was the main underground fan evasé, designed to direct the air flow horizontally and prevent rain or snow entering the ventilation shaft.<sup>67</sup> The surface fan impeller (blades) and motor were to the right. To the left was an airlock entrance allowing access to the fan housing. Anyone climbing the ladder in the ventilation shaft would also exit through the airlock.

53. On the top of the housing were four explosion panels, designed to allow a pressure wave of air and debris following an explosion to go straight through the top of the housing and minimise damage to the fan. The explosion panels are seen in black in Figure 8.5.
54. Because both the surface fan and main underground fan were connected to the same ventilation shaft, a system was needed to block off air flow through one or other easé, depending which was in use. Initially Fläkt Woods designed a butterfly damper for that purpose, but this was damaged and not repaired for 12 months or more.<sup>69</sup> During commissioning of the underground fan a few weeks before the explosion, Pike installed a set of louvres at the end of the main fan easé as shown below. These were designed to close if the main fan stopped and the surface fan started up to ventilate the mine.

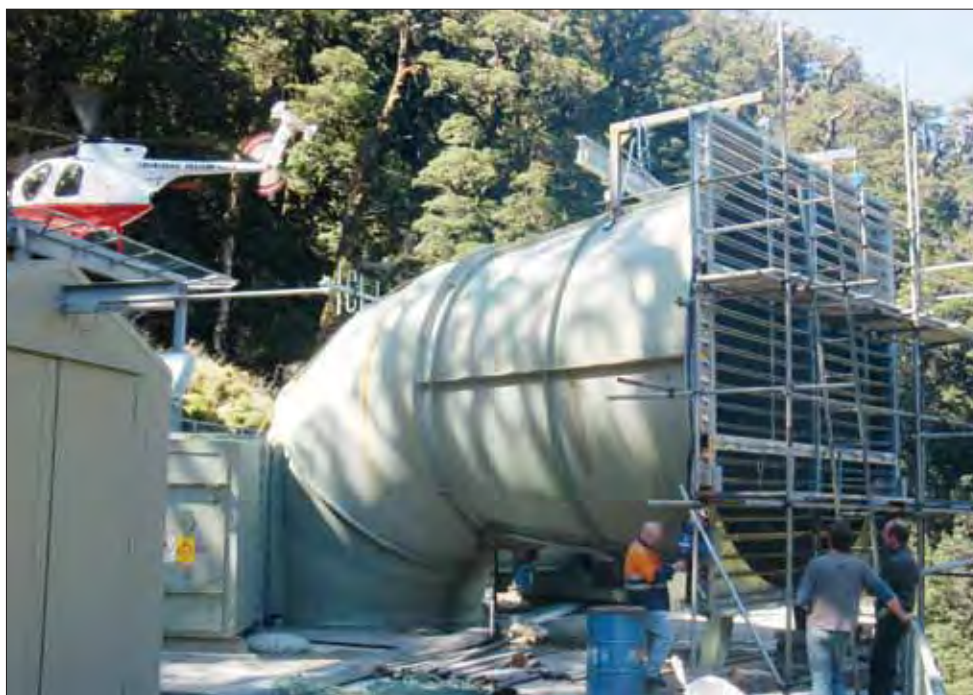
**Figure 8.7: Easé showing louvres being installed**

55. The surface fan was powered by electrical cabling that ran from the portal substation up the main drift and then to the surface via the shaft. This was unusual. It meant that if power was tripped to the main fan at the portal, for example because of methane in excess of 0.25% in the vicinity of the fan motor, power would also be unavailable to the surface fan. Accordingly, diesel generators were installed to start automatically if the main fan stopped, enabling the surface fan to operate.<sup>70</sup>

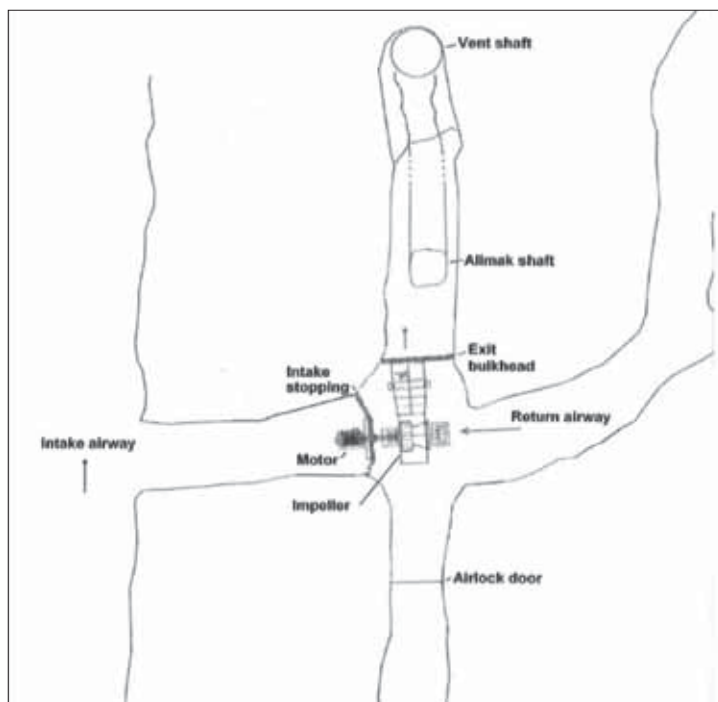
**Figure 8.9: Orientation and operation of underground fan**

62. Air entered from the return airway to the right of the diagram, then passed through the impeller and up the Alimak shaft. The non-flameproof motor was in fresh air on the intake side and sealed off from the fan impeller by a stopping, through which the drive shaft passed. The exit bulkhead was partly fitted with louvres, which were closed when the fan was working, but opened when it tripped. This enabled the surface fan to draw air more easily up the ventilation shaft to maintain mine ventilation. The airlock doors prevented return air from entering the mine intake system.

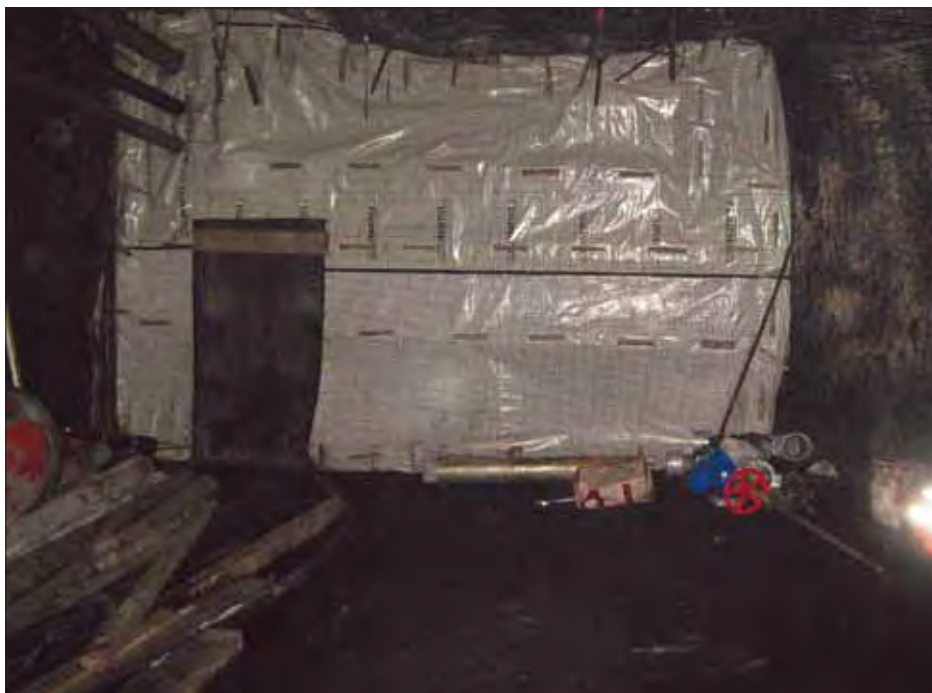
**Figure 8.12: Board and brattice stopping**<sup>148</sup>

104. Stoppings must be constructed to a suitable standard to avoid leakage, which can compromise the performance of the ventilation system. Stoppings should also be built to withstand the pressures that may follow a roof fall or windblast within the mine.<sup>149</sup>

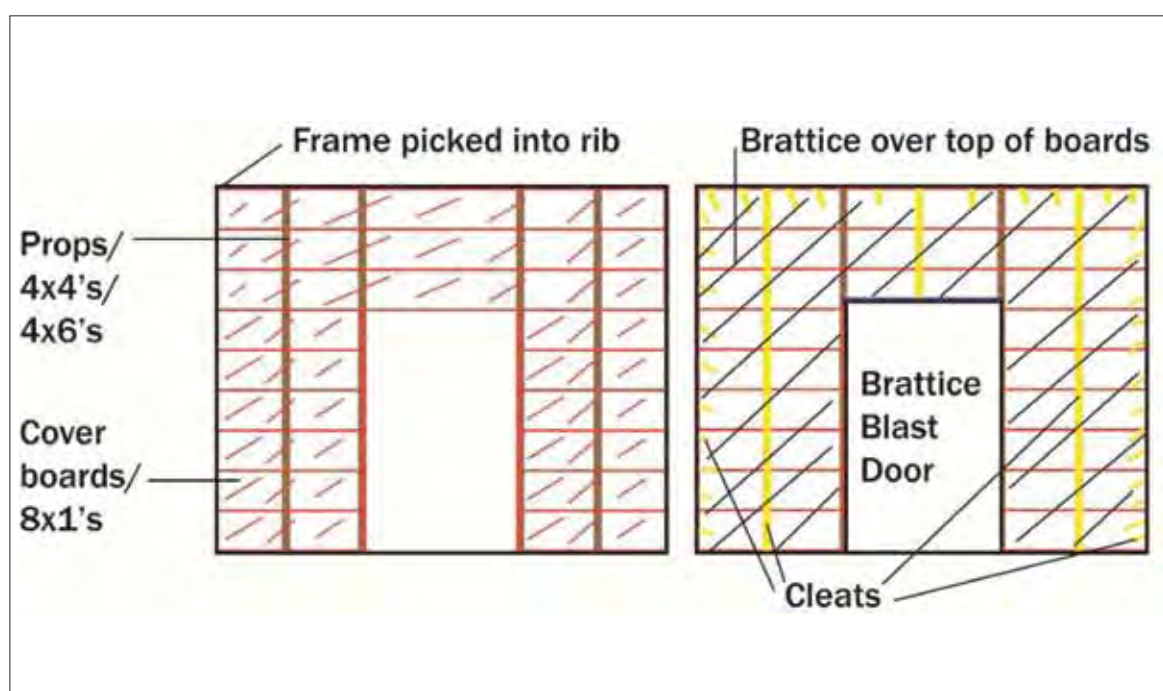
Figure 8.13: Board and brattice construction method<sup>162</sup>

113. In May 2010 Pike issued a standard operating procedure document entitled 'Underground Standards', which set out the standard for both temporary and permanent stoppings.<sup>161</sup> The basic construction method was the same for both, namely board and brattice construction, as depicted in the diagram below and in Figure 8.12.

114. The construction method was essentially to use standard timber covered by brattice. The main difference with permanent stoppings was that these were covered in mesh and sprayed with shotcrete (this is concrete or mortar

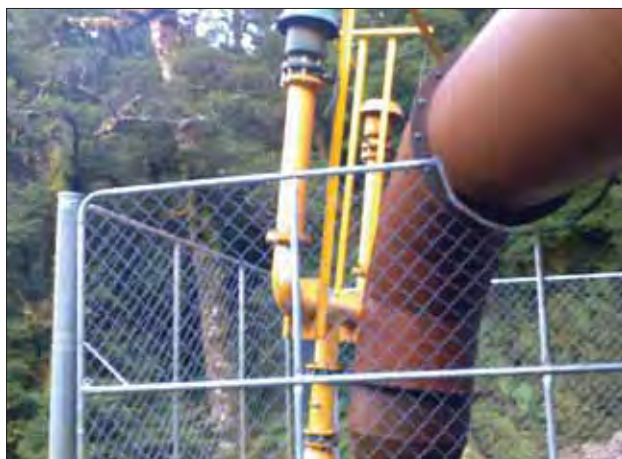
**Figure 9.4: Gas riser and slimline shaft<sup>45</sup>**

53. The collapse of the ventilation shaft on 2 February 2009 severely limited mine ventilation. To recover air capacity, Pike drilled the slimline shaft from the same surface drill pad location it had recently used to install the gas drainage system. Figure 9.4 below shows the gas riser (yellow) with flame arrestors, and the brown pipe is connected to the top of the slimline fresh air shaft.

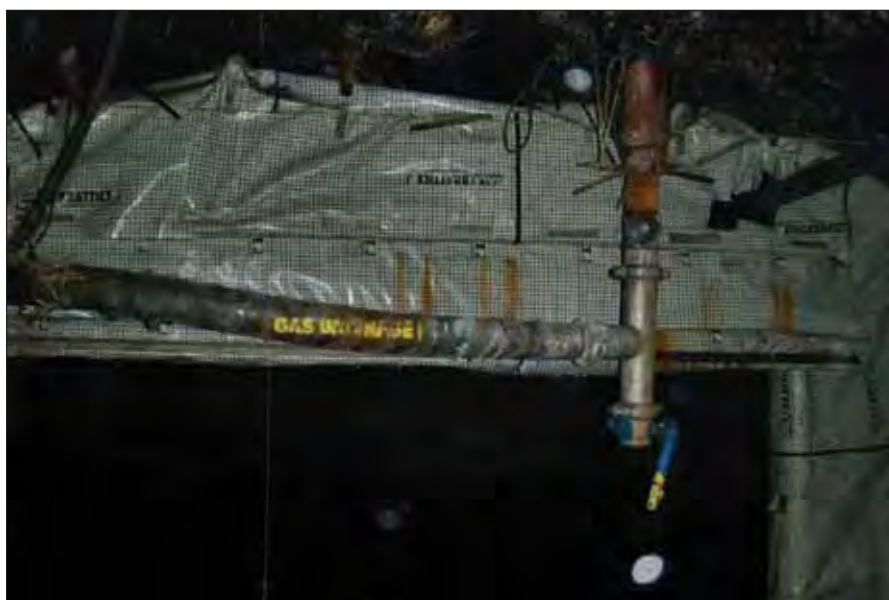
**Figure 9.5: Bottom of gas riser at entrance to the FAB**

54. The bottom of the 6" riser is shown below connected to the 4" gas drainage line labelled in yellow, at the entrance to what became the fresh air base (FAB) in mid-2010.<sup>46</sup>

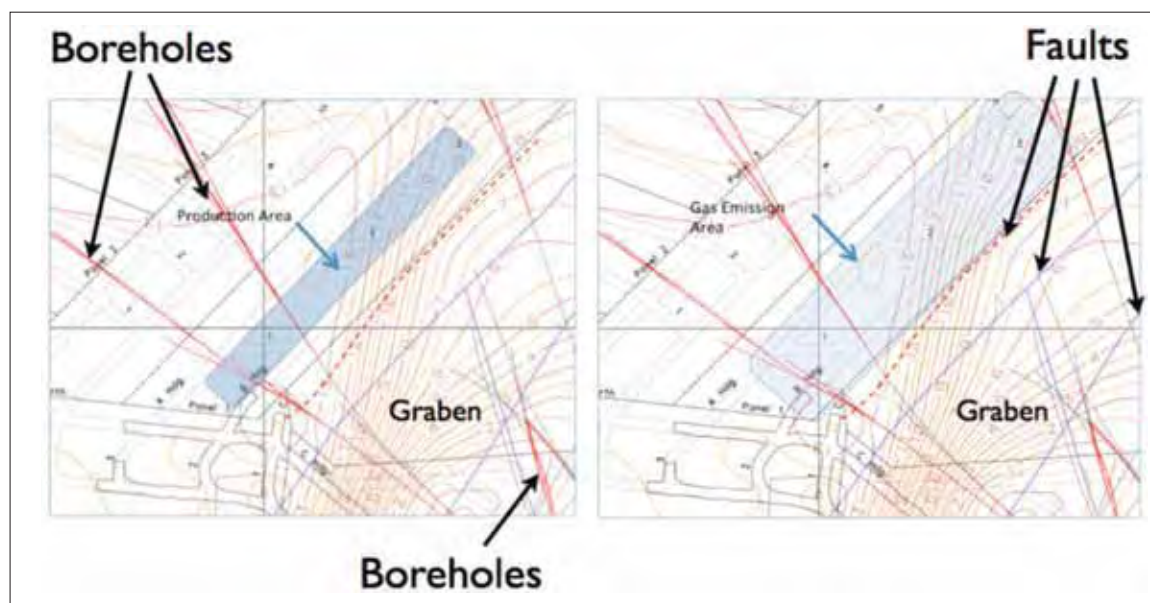
Figure 9.8: Panel 1 production area and panel 1 area of interest for gas emissions<sup>129</sup>

109. The following diagrams show the proposed production area of the hydro panel, and the expected gas emission area for gas flows from the surrounding strata.<sup>127</sup> Long in-seam boreholes intersect the panel,<sup>128</sup> and faulting to the east of the panel is shown.

110. Borehole GBH016 was subsequently drilled 'flanking' the eastern boundary of panel 1, but no drainage holes were drilled within or to the west of the panel. GBH016 and the intersected boreholes were designed primarily for exploration of the seam, not for systematic pre-drainage of methane from the panel before mining.<sup>130</sup>
111. The gas content core sample result of 8.29m<sup>3</sup>/t from GBH016 underlined the need for further drainage of the area, particularly given the use of an untried hydro-extraction method in a thick seam with the likelihood of high methane release. However, coal extraction from panel 1 began without pre-draining the seam down to safer gas levels.

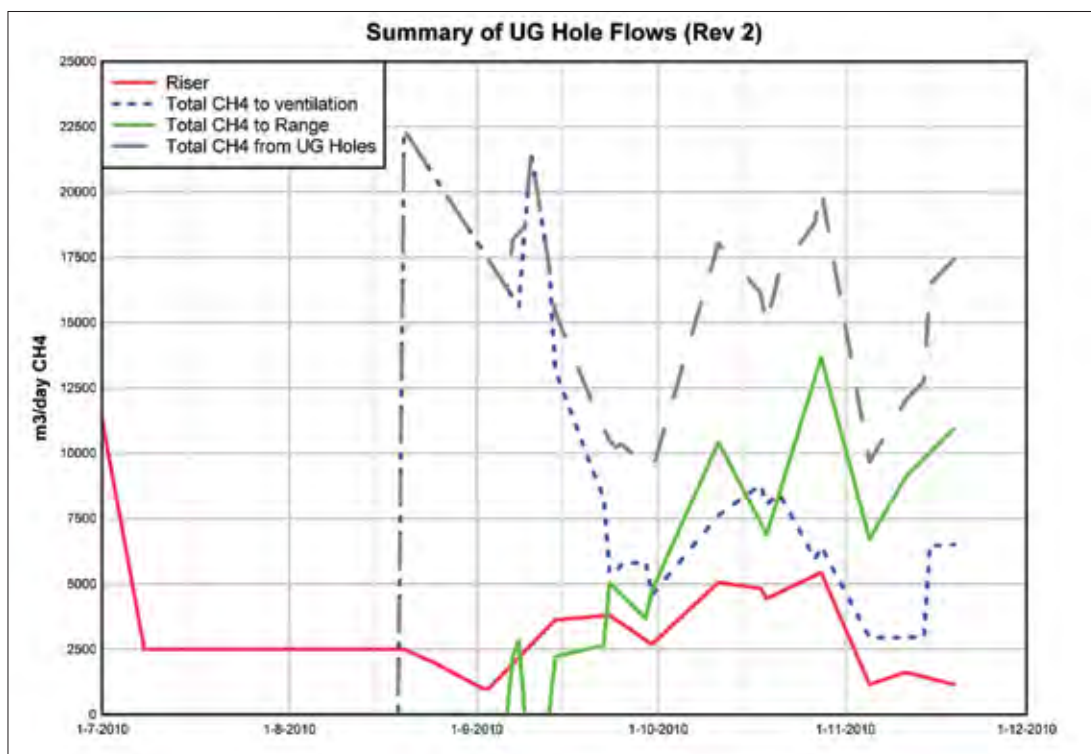
Figure 9.9: Graph summarising total daily drainage system gas flow measurements<sup>150</sup>

126. The following graph prepared by the joint investigation expert panel<sup>149</sup> summarises the total daily methane volumes ( $\text{m}^3/\text{day}$ ) for the drainage system gas from July 2010 until the explosion. The red line depicts the volume of methane measured at the bottom of the gas riser, which decreases from the beginning of July when the practice of free venting began with GBH012 disconnected from the range. The blue line shows the volume of methane free vented to the mine's atmosphere for dilution by ventilation; and the grey line shows the total methane flow from all boreholes. These measurements began on 20 August 2010, the start of gas flow measurement from individual boreholes. The green line shows the total methane volume flowing into the range from September 2010 when weekly gas drainage measurements commenced.

127. The noteworthy features are the high volume of methane free vented when compared to the volume of gas entering the range, and the difference between the volumes entering the range and reaching the bottom of the riser. For example, on the day of the explosion the measured gas flow into the range was 126.4l/s but only 13.3 l/s was measured at the gas riser. Such discrepancies dated back to the beginning of October. Various explanations for the difference have been suggested including leakage, methane back-feeding into other areas, a blockage in the range or incorrect measurements at the gas riser.<sup>151</sup>
128. As late as 27 October 2010, there was no accurate recording of methane emissions and no comprehensive system in place to capture, record and store all data permanently.<sup>152</sup>
129. The expert panel criticised Pike's gas management approach:

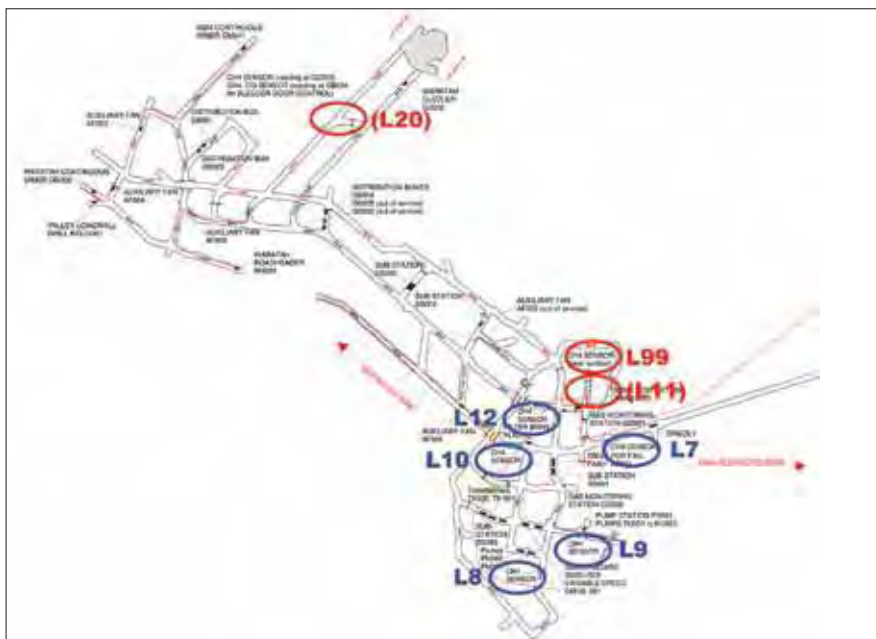
Figure 10.1: Location of fixed methane sensors<sup>22</sup>

11. As at 19 November 2010 there were eight fixed methane sensors connected to the surface control room,<sup>21</sup> shown in Figure 10.1.
