Hydro-panel sensors

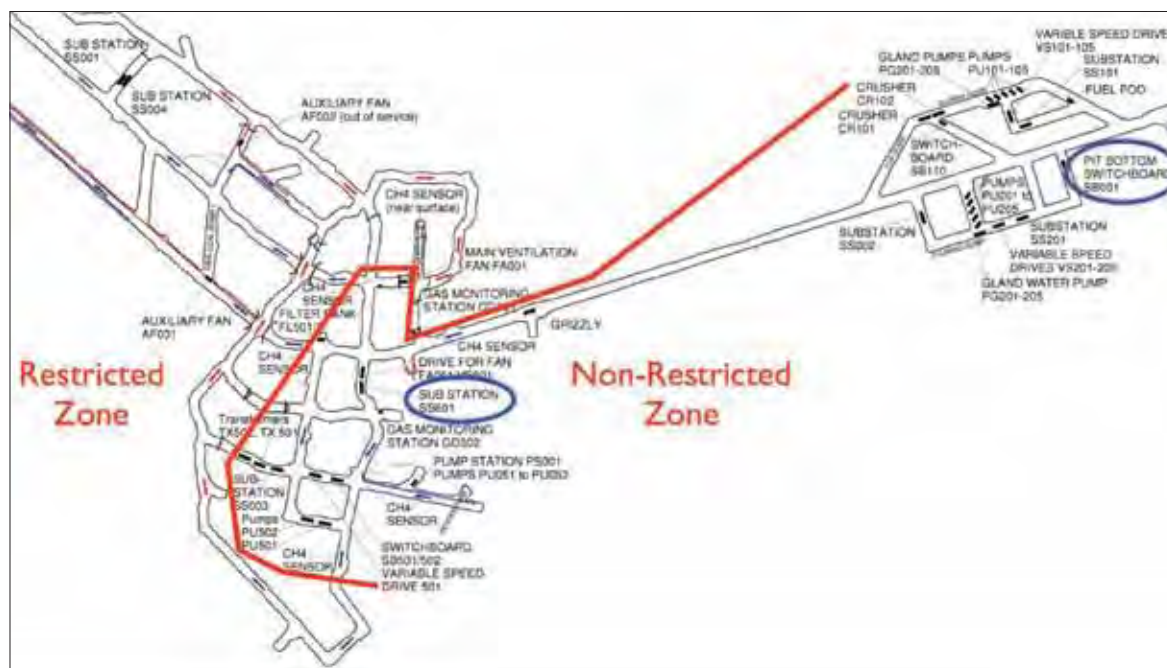
Figure 11.1: Main electrical area and zones underground²

9. The red line in Figure 11.1 marks the boundary between two underground zones, the restricted zone, which is to the left of the line and includes the coal workings, and the non-restricted zone to the right. That non-restricted zone includes Spaghetti Junction and much of pit bottom south. The zones are explained below.

19. A stopping failure or ventilation fan failure (which may be followed by the reversal of ventilation) could result in methane being introduced into the pit bottom south non-restricted zone.¹³ Because some equipment in that zone was not intrinsically safe or flameproof, methane sensors and the associated safety cutouts had to be relied on if methane entered the area.

23. The inclusion of pit bottom south and Spaghetti Junction in the non-restricted zone led to another hazard. These areas contained roadways and significant utility services – water pipes, compressed air pipes and gas drainage pipes. To those were added 11kV lines. The sheer quantity, and lack of separation, of utility services at Spaghetti Junction is shown in Figure 11.2. The high-voltage cables are red.

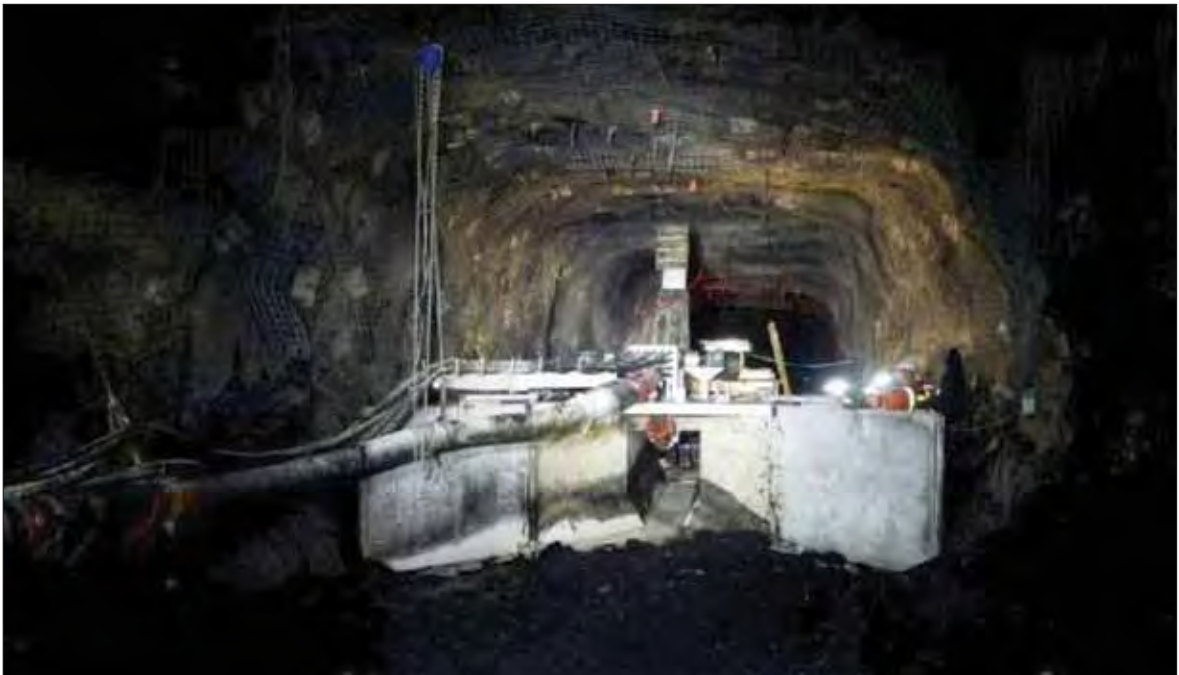
Figure 12.4: Guzzler ready to gather and direct water/coal mixture⁶

5. At Pike River a machine called a guzzler was located 18m behind the hydro monitor, and directed the mixture of coal and water into the roadway flume system. The guzzler also crushed any large lumps of coal.⁵ It is shown in the photograph with its 'wings' open ready to gather and direct the coal/water mixture.

54. Mr Nishioka's work record during the monitor's first week of operation noted that:
- the guzzler was too large and complicated;
 - it was hard for the operator to see the direction of the monitor nozzle, because vision was blocked by the housing;

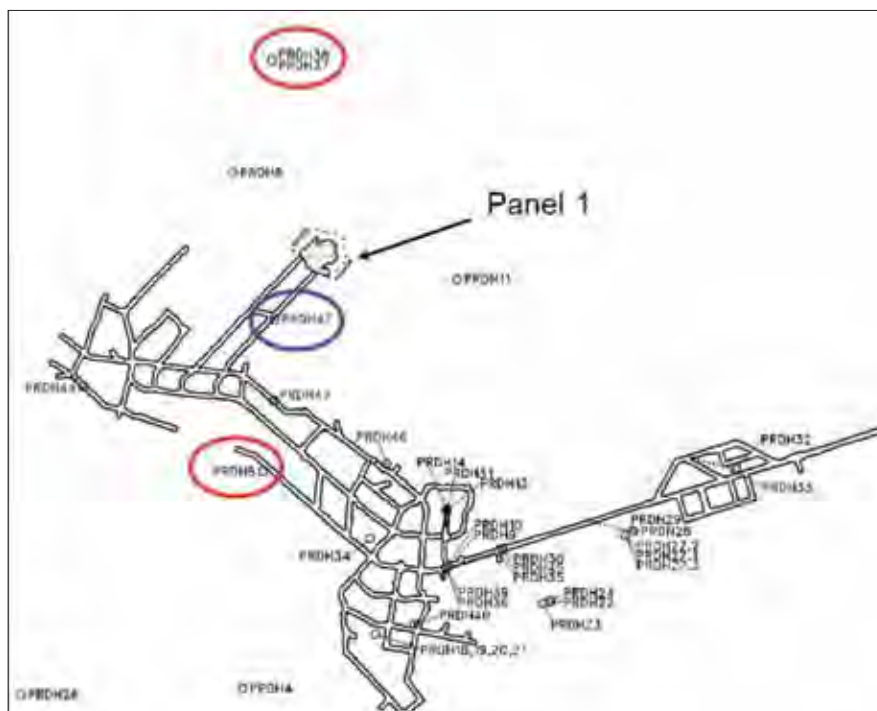
Figure 12.12: Drillholes in the vicinity of Panel 1⁷⁷

63. In July 2010, as part of its annual insurance risk assessment, Hawcroft Consulting 'strongly recommended' Pike undertake a thorough risk assessment into the potential for windblast before coal extraction began in panel 1.⁷⁶
64. On approximately 3 September 2010 Pike carried out the 'panel 1' risk assessment, which dealt with many aspects of windblast. However, Pike had inadequate information to assess the likelihood of windblast occurring and, as noted above, many of the 'existing controls' relied on in the risk assessment did not exist or were ineffective.
65. There was no vertical borehole in the area of the hydro panel, so the only geotechnical data available was from vertical drillholes PRDH8 and PRDH37. These were some distance apart to the south and north of panel 1, as shown below circled in red. PRDH47 (shown below circled in blue) was not drilled until after the explosion.

66. Consultants Strata Engineering used information from drillholes PRDH8 and PRDH37 to provide Pike with windblast advice on 29 August 2010, and Pike relied on this advice repeatedly in the risk assessment. The advice noted that Pike River's bridging panels were planned to be 31m wide in the first instance, but might increase to 50m in the future, with an extraction height in the 10–13m range.⁷⁸ Pike generally took Strata Engineering's advice, based on modelling, as encouraging about the windblast hazard. The island sandstone was considered likely to bridge over panel widths of up to 30m, and although it might fail over larger distances, this was likely to be progressively in smaller blocks rather than a large plate-like fall associated with windblast.⁷⁹

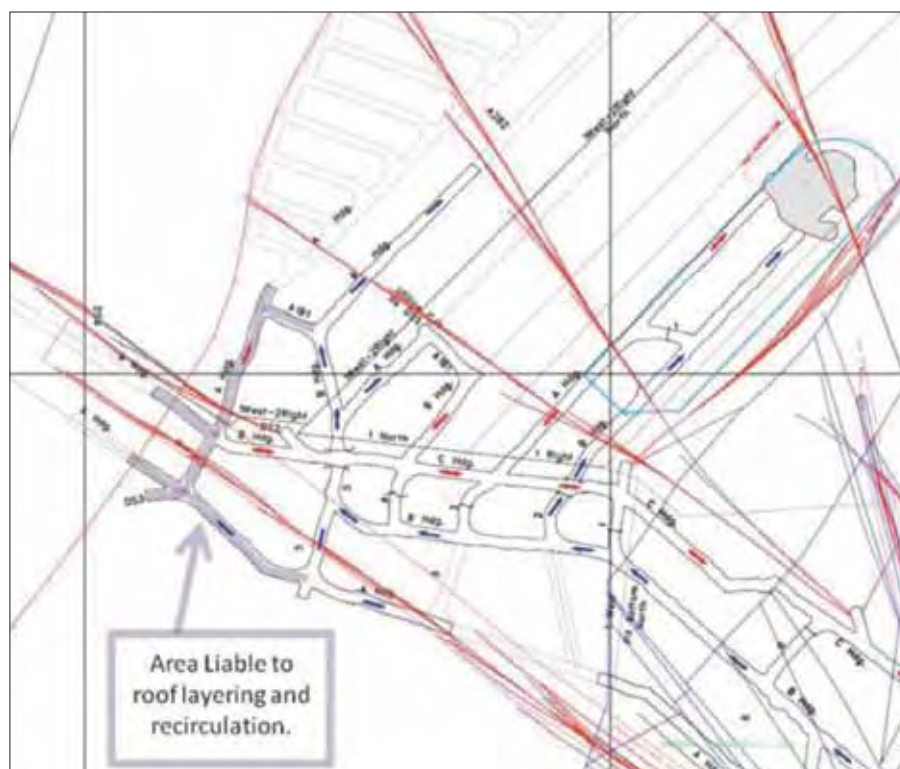
Figure 14.2: The area of the goaf and the intersecting borehole¹⁵

33. The expert panel concluded that there were few potential locations within the mine capable of producing the required volume of methane. One possible location was the hydro panel goaf.
34. Hydro mining at Pike River had created an irregular goaf approximately 30m wide, 40m deep and up to 9m high. The void volume was approximately 6000m³. The goaf was not ventilated. Methane would have continued to bleed from the coal seam into the goaf.¹³ It also contained an in-seam borehole drilled to explore the limits of the seam and also pre-drain methane. The borehole had been intersected during hydro mining, and therefore provided an additional potential source of methane.¹⁴ The diagram below illustrates the area of the goaf (top right corner) and the intersecting borehole. The gas drainage lines are marked in red.

There was also a rider seam above the goaf which, after disturbance of the roof strata during mining activity, could leach further methane into the goaf.

42. The third, and 'less likely,' scenario was a gas accumulation centred in the most inbye and western area of the mine, where the two continuous miners, the roadheader and the in-seam drilling rig were located. This area is depicted in Figure 14.2 and labelled 'area liable to roof layering and recirculation'. There had previously been ventilation and gas management problems in this area, which triggered the shutdown of machinery and the initiation of various methane control measures. In giving evidence, Mr Reece said scenario three was considered less likely because of the significant volume of methane required, which experienced workers, and statutory officials, should have detected and reacted to.²²

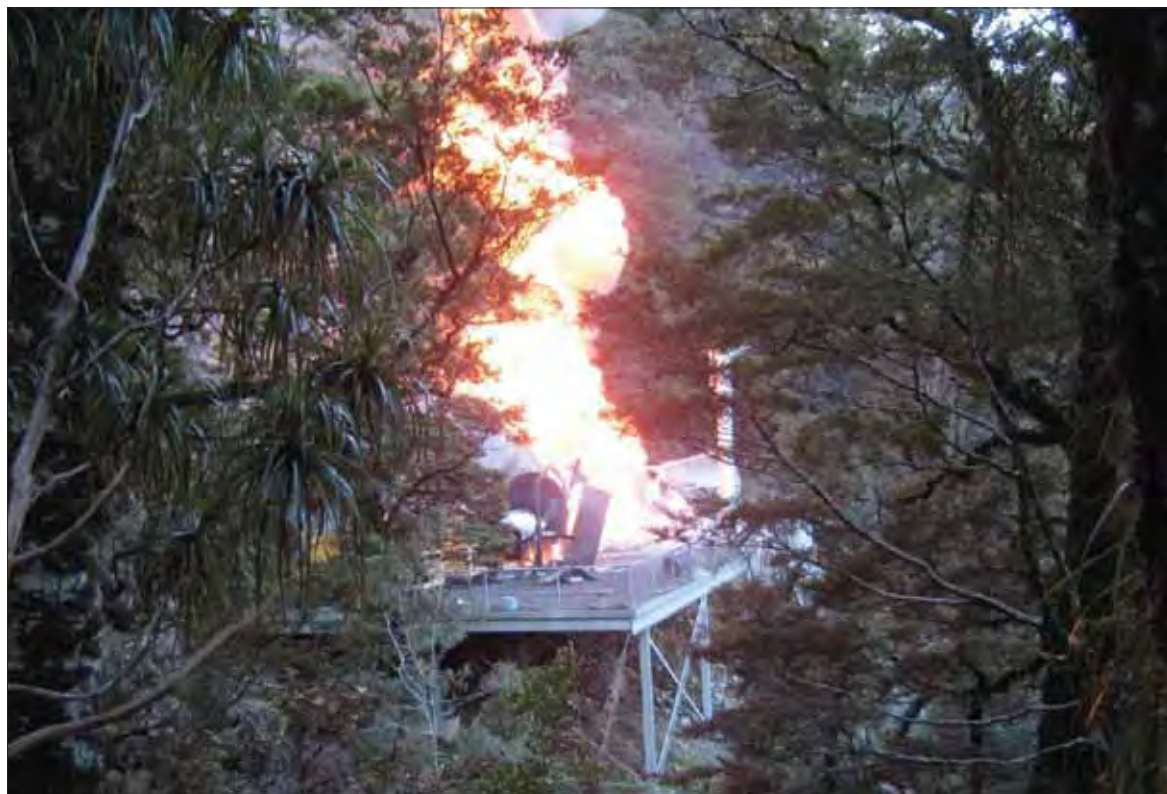
Figure 14.4: Fire coming from the ventilation shaft following the fourth explosion⁷⁴

88. The later explosions differed from the first. The second and third explosions had a duration of 30 and 23 seconds at the portal, respectively. Both caused a much more forceful pressure wave than that from the first explosion. Following the pressure wave, air was initially drawn into the drift and then there was a reversal or expulsion of air.⁷²
89. The fourth explosion was different again. It caused a billow of black smoke, followed by a fire ball out of the vent shaft and, subsequently, flames that diminished over time, but continued to be visible until 8 December.⁷³
